Association between Lineaments and Groundwater Intrusion into Tunnel Built in Granitic Rock Mass

H. Hussin^{1,2*}, M. H. Arifin¹, T. A. Jamaluddin¹, M. F. A. Ghani¹, N. Ismail³

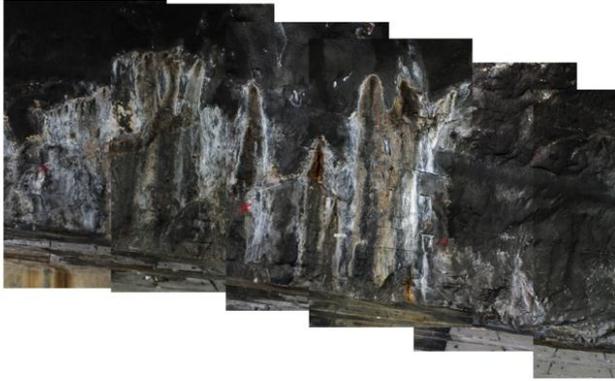
15		ENGINEERING GEOLOGICAL MAPPING FOR STABILITY ASSESSMENT OF CA	
LEFT WALL

CH	420	425	
GEOLOGY	[
GEOTECH PROBLEMS / ISSUES	(Wet zone, excessive seepages corrosion to rock dowels/bolts water drain out of rock bolts)

Fig. 3: Example of tunnel mapping conducted during field assessment

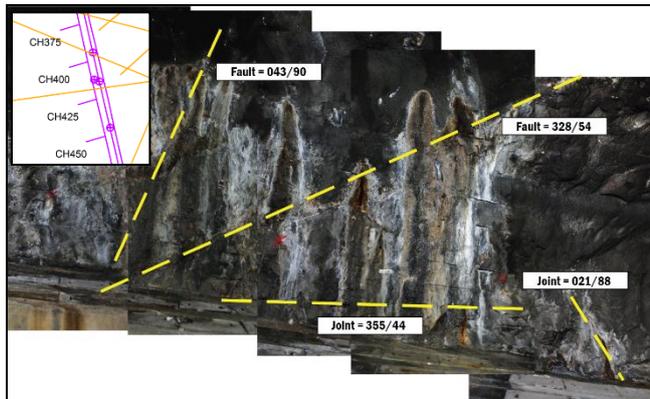
However, the most predominant sets are the NW-SE and NE-SW lineaments. Generally, lineaments features are existing from along both tunnel (main and ventilation tunnel), but more focussed from CH 50-375 and CH 550-800 in the main tunnel. Other parts of tunnel are slightly effected by lineaments, while for ventilation tunnel, lineaments are mostly concentrated from CH 150-275, CH 325-400 and CH 625-725. The correctness of lineament interpretation is verified at the site. Based on the structural mapping in the field, these lineaments sets correspond to the faults and major joints (Fig. 5).

Fig. 5: Some fault structure measured in CH 420-425 in ventilation tunnel. These fault zones are represented in the lineament as interpreted in satellite image

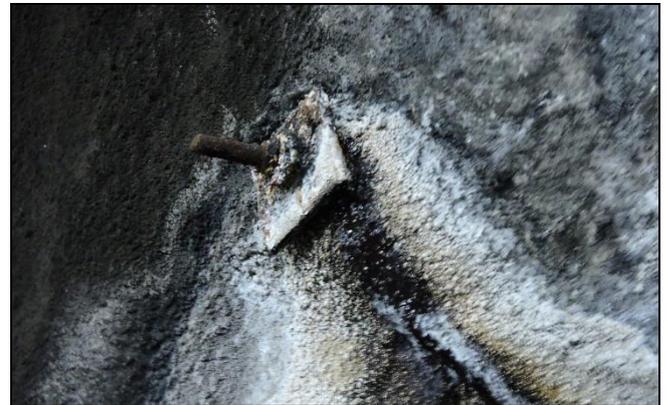
Groundwater intrusion into tunnel is a problematic situation in the study area. Multiple complications associated with groundwater intrusion are identified, examples being corrosion to tunnel support system (Fig. 6), deposition of secondary mineral and clog-up of installed drainage system. Field mapping, to sort and locate water seepages, was conducted from end to end inside the tunnel. Results of water intrusion mapping show significant locations of groundwater intrusion along tunnel. There are five conditions of water intrusion which are: past moisture, dump, standing drop, dripping and flowing (Fig. 7). Flowing and dripping were very common along tunnels, while dump and past moisture were not quite common. The meaning of terms used for groundwater intrusion is explained in Table 1. Calcite mineral deposit is a common feature that can be observed at locations of groundwater intrusion. Almost 50% of total length of the tunnel is affected by groundwa-

Fig. 6: Heavily corroded rock bolt coated by secondary calcite

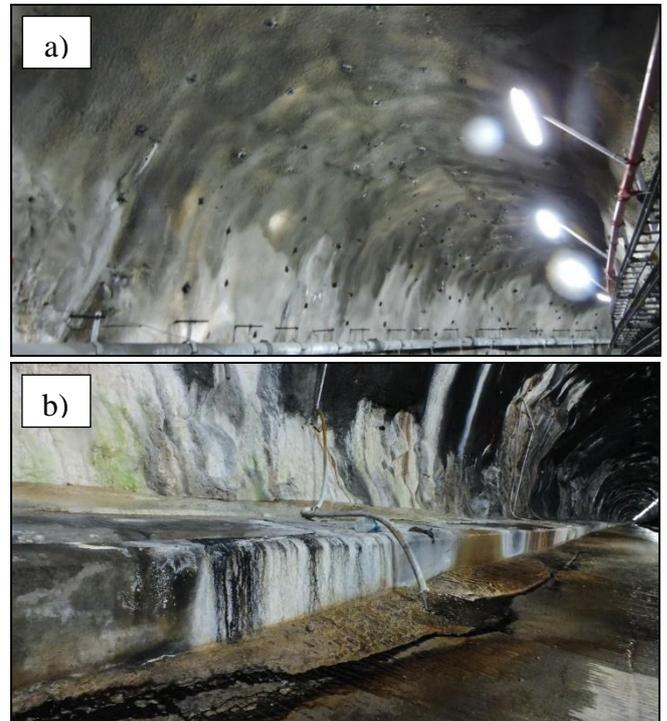
Fig. 7: Two different situations of groundwater intrusion, a) dumb, b) flow

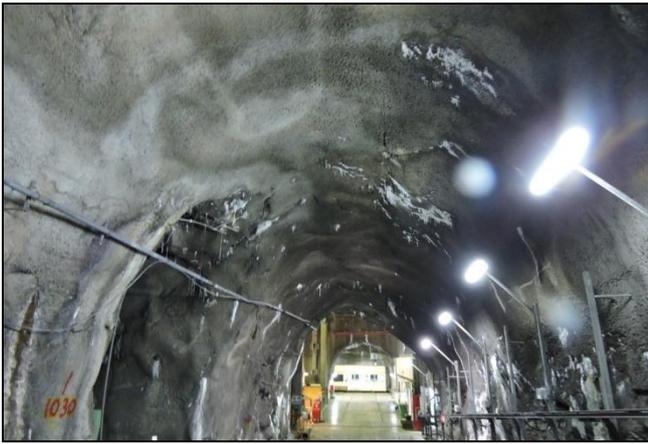
ter intrusion. Intrusion is flowing out from both side of wall and crown (Fig. 8). Summary of groundwater intrusion locations along main and ventilation tunnels are shown in Fig. 9 and Table 2.

Fig. 8: Groundwater intrusion can occur either at crown or wall of tunnel. Calcite mineral deposit is a typical feature that can be observed at locations of groundwater intrusion

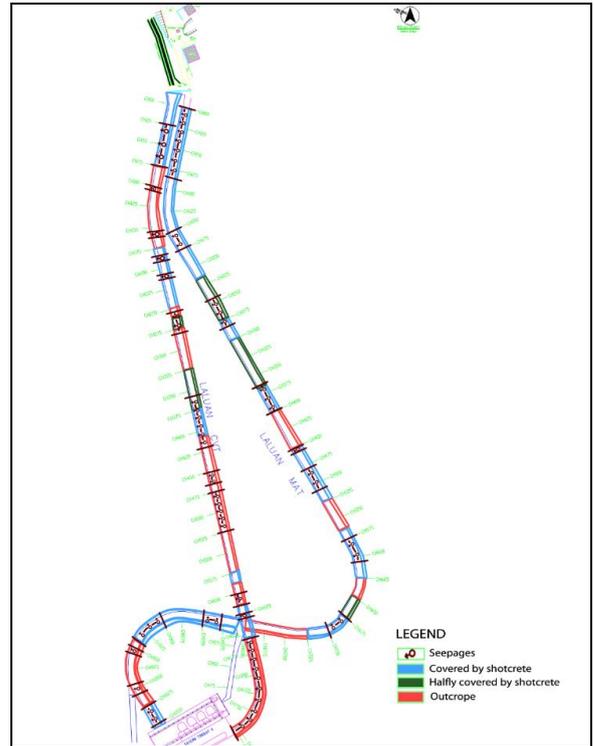
The distribution of groundwater intrusion is not concentrated at certain locations, but it is dispensed along tunnels from end to end. In main tunnel, the area most affected by groundwater is CH 0-80, while in ventilation tunnel, it is predominately at CH 650-780. Other areas affected by groundwater intrusion were the middle of tunnel, mainly at CH 250-275, CH 350-425 and CH 475-525. Groundwater is shown to be flowing along major geological structures, especially joints and faults. Some locations with high intensity of geological structures have excessive amount of groundwater and vice-versa. Other than geological structures, a few intrusions also occur via man-made holes, especially rock bolt and weep holes.

Fig. 9: Summary of water seepages/wet zones along main and ventilation tunnels

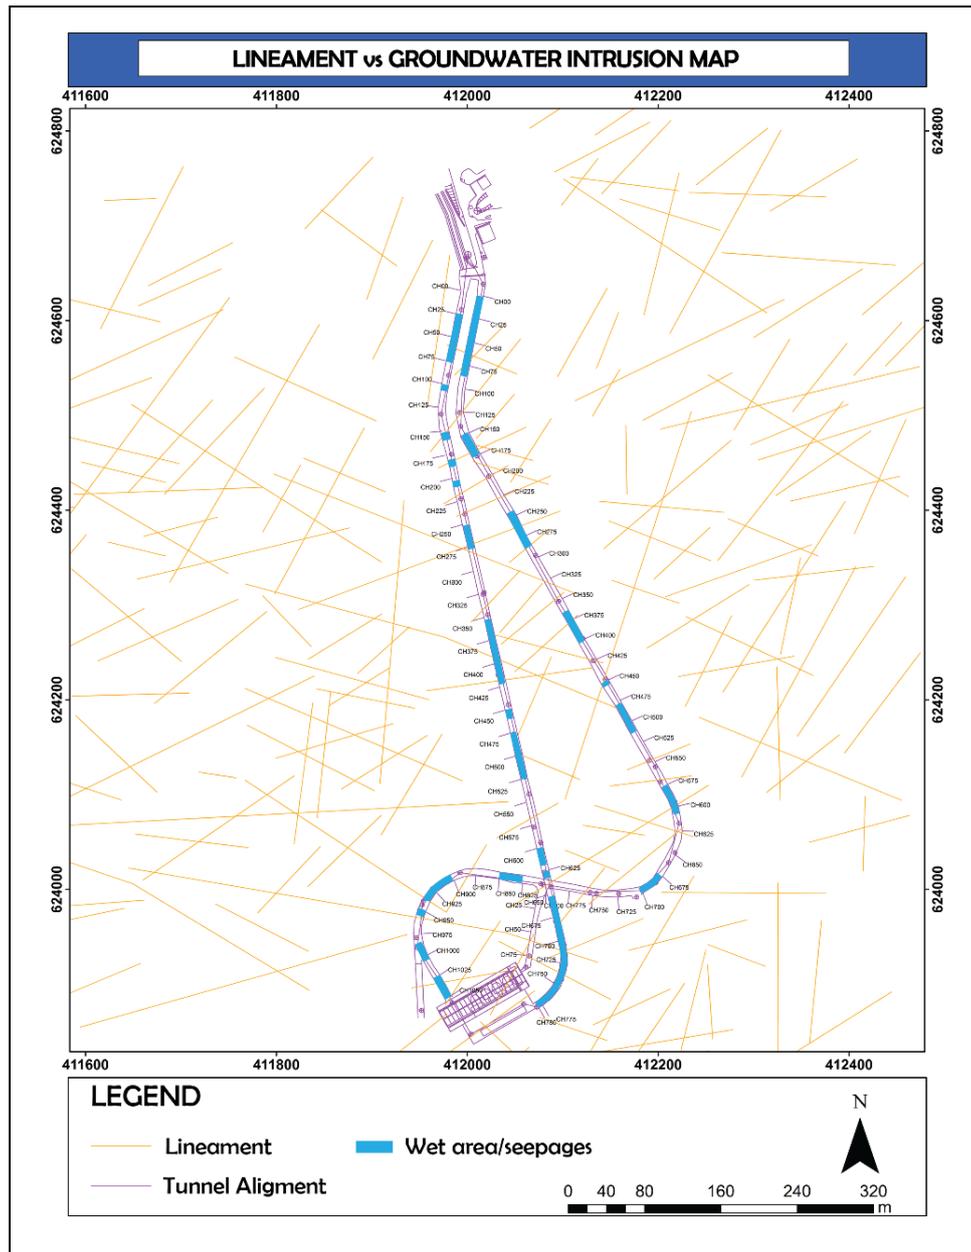
Maps of lineament interpretation and groundwater intrusion are combined together, as shown in Fig. 10. The comparison between lineament and groundwater intrusion shows both data are related to each other. Each section or location where groundwater intrudes into tunnel, presence of lineament(s) can be noticed. Groundwater can flow efficiently through these geological structures, which are well-connected to each other, and thusly increases porosity and permeability. For example, at groundwater intrusion from CH 350-425 in ventilation tunnel, six lineaments are identified to be present. Similar setting also can be seen at other locations along tunnel, for instance from CH 475-525, CH 625-780 in ventilation tunnel and CH 150-175, CH 250-275 and CH 1025-1050 in main tunnel.

The number of lineaments differ from one location to another and it does not influence coverage area of groundwater intrusion into tunnel. For example, total groundwater affected are in main tunnel from CH 0-80 is 80m, but number of lineaments identified at that section are two. However, for 75m length of CH 350-425 in ventilation tunnel, identified lineaments are six. Therefore, it can be

Fig. 10: Compilation of lineament and groundwater intrusion map
