Analysis of Cracks on a Fractured Surface of the Vehicle Crankshaft Using the Finite Element Method

Husaini*, T.E. Putra, Zulfikar

Abstract

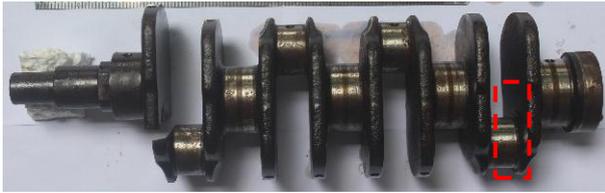
In this study, the material used was alloy steel taken from the car crankshaft. First, observations were made to determine the mechanical properties of the material. The visual inspection showed a crack on the crankshaft with the engine rotation speed of 5500 RPM [9]. The crankshaft broken on crank pin number 1, as shown in Fig.ure 2. The visual inspection showed a beach mark on the fracture surface [10], as shown in Fig.ure 3, characterizing the cause of the failure.

Fig. 2: The failure of the crankshaft.

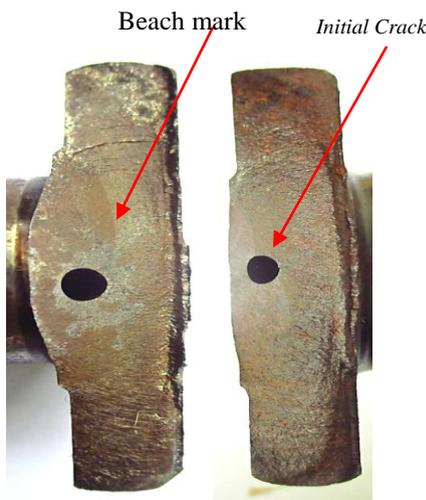
Fig. 3: The surface is broken on the crankshaft at the crank pin number 1.

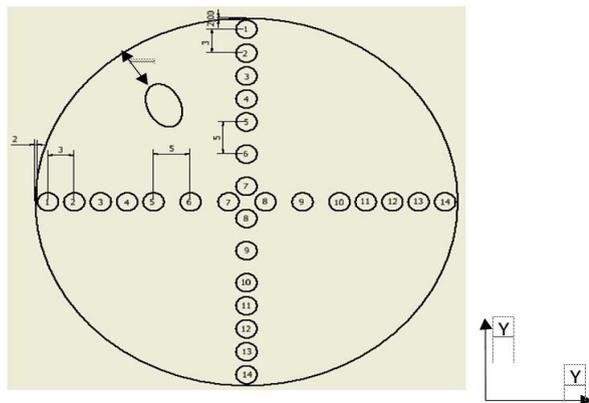
From the hardness testing results, it was found that the highest hardness value was on the outer shell portion of the crankshaft on the X and Y axes at points 1 and 14, which were 102.2 HRB. The hardness testing point can be seen in Figure 7. Figure 8 shows that the highest hardness values are at points 1 and 14, which are at the edges of the cylindrical specimens as shown in Figure 7. The hardness of the shaft at the edges larger than the middle portion is aimed at avoiding defects and rapid thrust on the shaft during work.

Fig. 7 : Hardness testing point

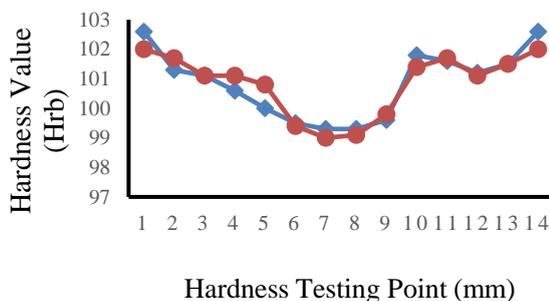
Fig. 8 : The graph of the hardness values (in HRB)

It was found that the hardness depth of about 13 mm from the outer surface of the crankshaft, namely from point 1 to 4 as shown in Figure 8, which also indicates the cause of failure. The heat treatment process was not suitable as the crankshaft was harder than the standard AISI 1060 material for approximately 89 HRB. Therefore, the hardness of the crankshaft was in excess of the standard, thus caused the fatigue failure.

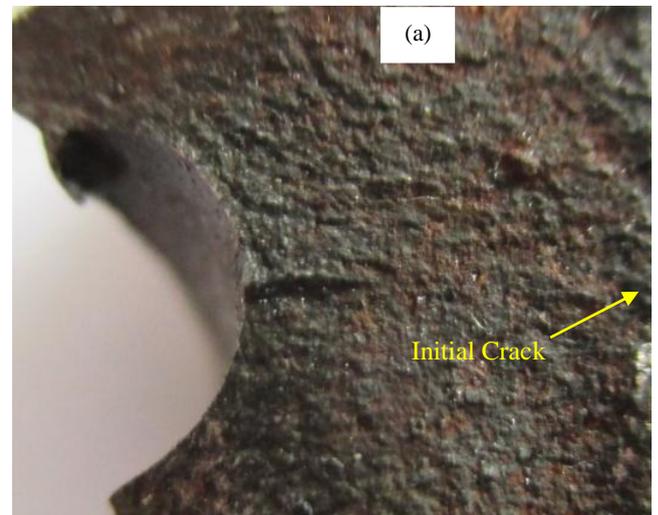
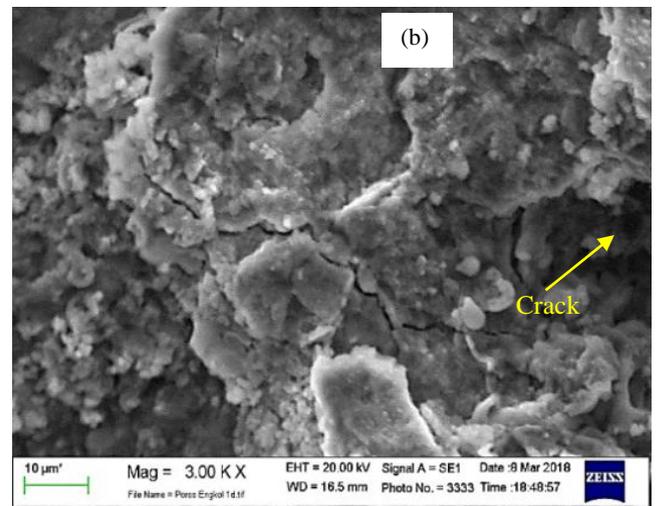
According to the SEM observation (SEM type EVO MA10), with enlargement of 3000x, there was a crack around oil hole on the crankshaft of pin 1 seen due to lack of care, negligence in the installation process, and a scratch with a sharp object resulting in the defect. The initial crack can be seen in Figure 9.

Fig. 9 : (a) Visual observation of the initial crack on the fracture surface and (b) SEM image on the fracture surface at the initial crack.

Observation of the factography using SEM as shown in Figure 9 shows the existence of the initial crack. However, the crankshaft remains a failure caused by the fatigue failure due to the dynamic loading through the beach mark on the crankshaft fracture surface that characterizes the fatigue failure as shown in Figure 3. Another cause was material hardness that was too deep by 13 mm from the outer surface of the crankshaft, making the crankshaft too hard and prone to fracture, as shown in Figure 8.

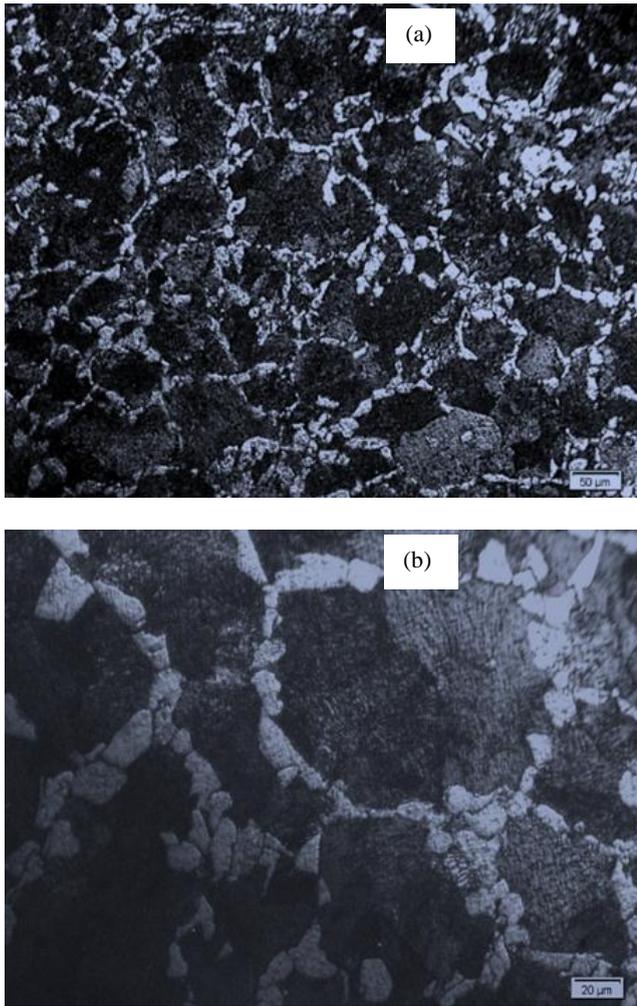
The microstructure test shows that the matrix was ferrite and pearlite with mean hardness value on x axis 100.85 and on y axis 100.83 HRB, showing that this material belongs to the steel hypoeutectoid, consisting of carbon content between 0.02-0.76% [14]. Figure 10 shows the results of microstructure testing with 20 times and 50 times magnification.

Fig. 10 : (a) The result of microstructure testing taken from the crankshaft (b) The result of the microstructure test taken from the crankshaft of magnification of the picture a.

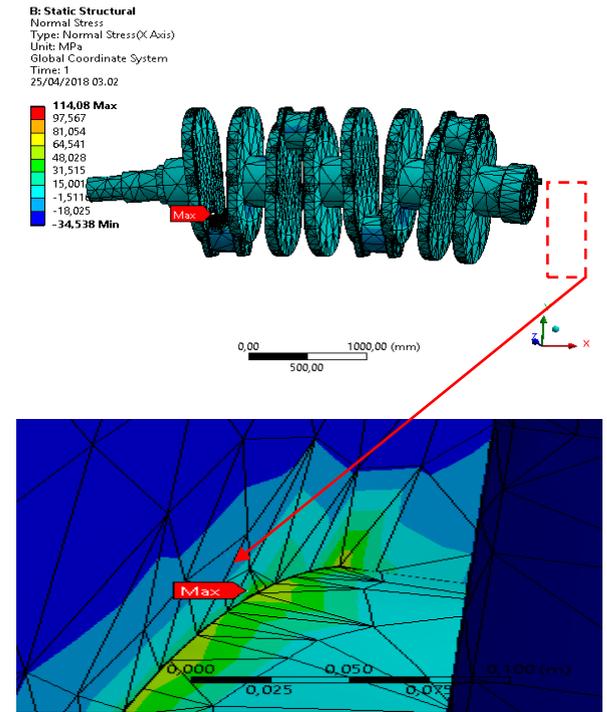
The finite element analysis result shows that the maximum critical stress area was on the crank pin number 1, which was 98.235 MPa, especially in the radius of the crank pin due to the initial crack in the radius part of the crankshaft. Figure 11 shows the maximum equivalent stress result with the value of approximately 166 MPa.

Fig. 11 : (a) Equivalent stress and (b) Enlargment at the maximum

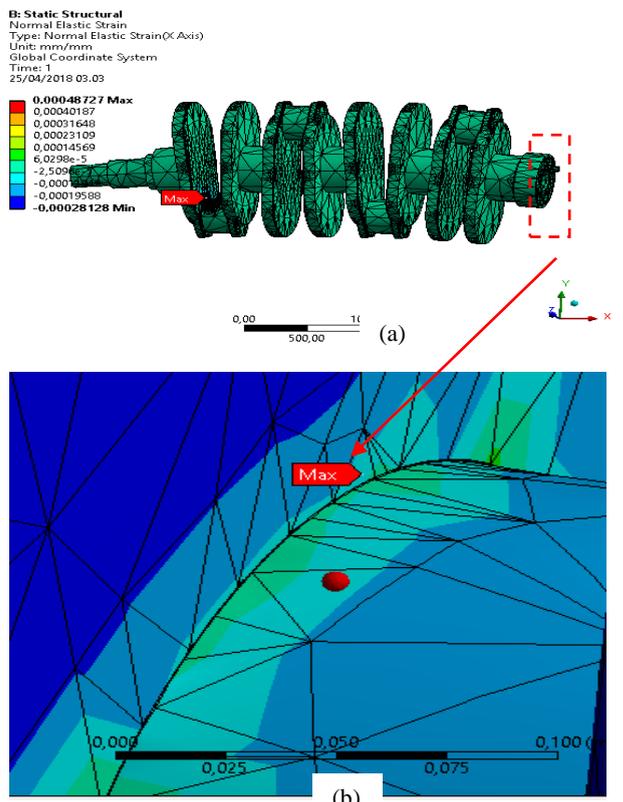
Finite element analysis results show that the maximum strain value was 3892×10^{-3} caused by the initial crack in the radius of the crank pin, making it the most critical area when the load was applied as seen in Figure 12. The maximum deformation value was 2.952 mm, as shown in Figure 13.

Fig. 12 : (a) Equivalent strain and (b) Enlargment at the maximum

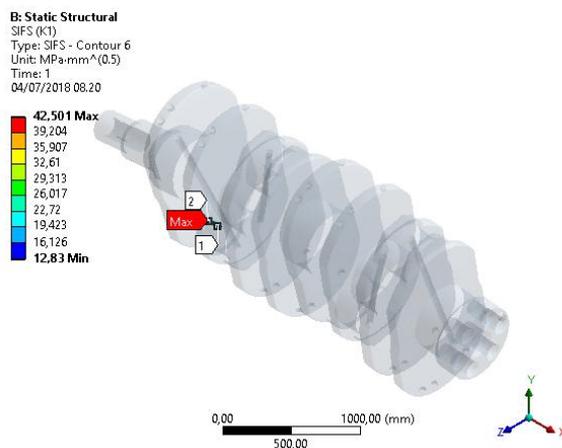
After SEM observation and observation of the crack, element analysis was done to determine the value of the maximum stress intensity factor that occurs on the crankshaft, which was 4.6 MPa $\sqrt{\text{m}}$ with the given stress was obtained on finite element analysis. Figure 14 shows the value of the stress intensity factor.

Fig. 14 : The value of maximum stress intensity factor
