# Occupational Health and Safety legislative compliance in the construction sites in Windhoek, Namibia

## Abstract

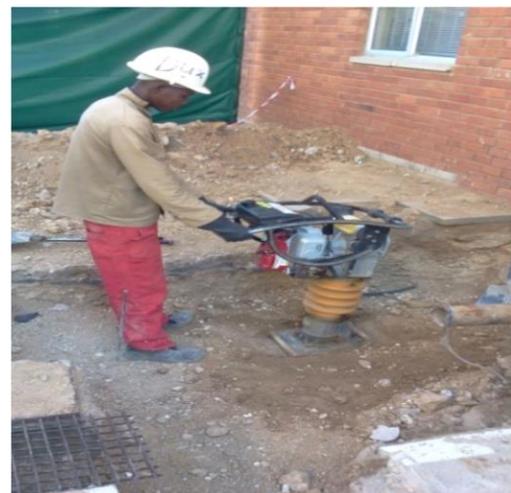
The study shows that all physical hazards, such as noise, dust, vibration and non-ionized radiation, were found at all construction sites. Examples of the observed physical hazard include whole-body vibration resulting from the use of heavy machinery, as shown in figure 1.

**Fig. 1:** Picture depicting a construction worker using a jack hammer at a construction site.

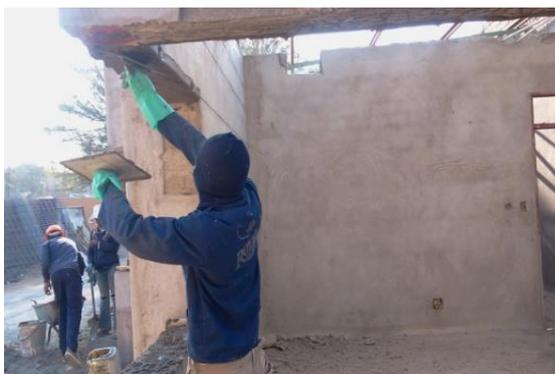
Figure 2 shows a construction worker plastering a wall. The job requires a repetitive movement and awkward posture for him to work with hands above the shoulder level for an extended period and excessive reaching to plaster the wall above the head height. In addition, the plastering work requires the worker to perform repetitive movement of bending to get the plaster from the trolley, putting it on the hawk, and spreading the plaster on the wall using the float. The plastering activity involves repetitive movement of the arm, shoulder, neck and waist.

**Fig. 2:**Picture depicting a construction worker performing repetitive movements.

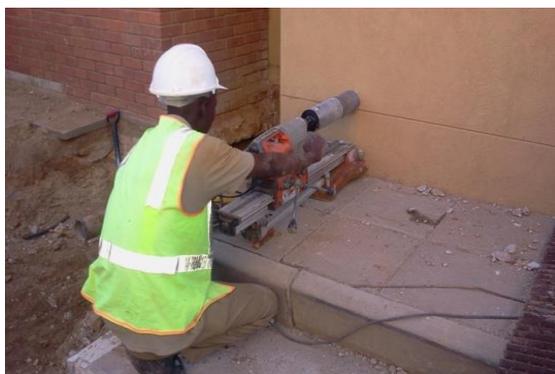
The photograph in figure 3, showing a worker using a core drilling machine to make a hole in the wall, depicts an image of a worker who spends an extended period in an awkward posture. It can be noted that the worker is performing work on a very low surface which requires him to kneel or squat. The awkward posture strains the worker's knees, lower back and the neck.

**Fig. 3:** Picture depicting a worker exposed to vibration while adopting an awkward posture at the study site.

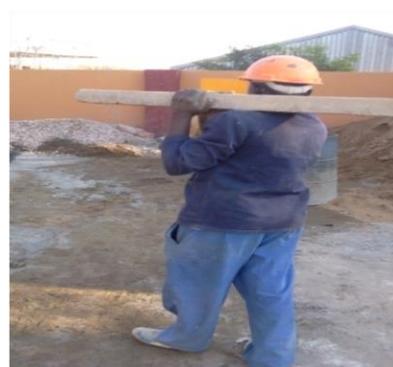
Depicted in figure 4 is a worker carrying a heavy load resulting in strains over the neck and left shoulder. Material handling and frequent lifting of objects strains the shoulder and arms. The picture shows a worker with both hands holding the load to secure it, which causes both arms to be above the shoulder level.

**Fig.4:**A Photograph showing a construction worker lifting heavy loads.

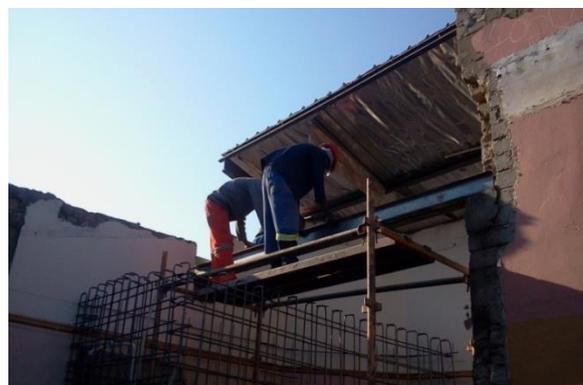
Bending and twisting is one of the ergonomic hazards observed at the construction sites during the site inspection. Figure 5 portrays the photograph of bricklayers laying bricks in the bending positions. Bending for a longer period could lead to back pain.

**Fig. 5:**A photograph showing construction workers performing work in bending positions.

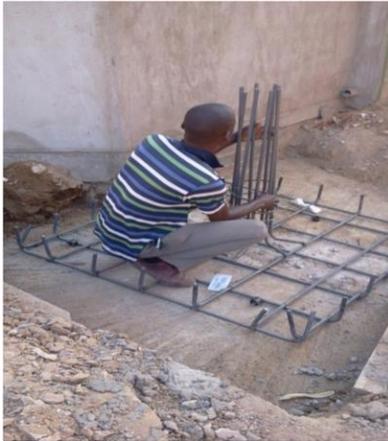
The researcher observed, during inspection surveys conducted at all 10 construction sites, whether workers were using PPE while performing their duties. The analysis shows that workers at 50% of the construction sites were using PPE such as blue overalls, face masks and safety boots, while other 50% construction workers were not using PPE as depicted in figure 6. Furthermore, 50% of construction sites were observed to have workers with PPE that was in good condition and not worn out. Surprisingly, only 30% of the construction sites had a list of workers who had been trained on PPE use.

Fig. 6:A Picture of a construction worker not wearing any PPE.
