Influence of Soil Liquefaction on the Structural Performance of Bridges During Earthquakes: Showa Bridge as A Case Study

Keywords: *Liquefaction; earthquakes; Piles supported bridges; Showa Bridge; collapse.*

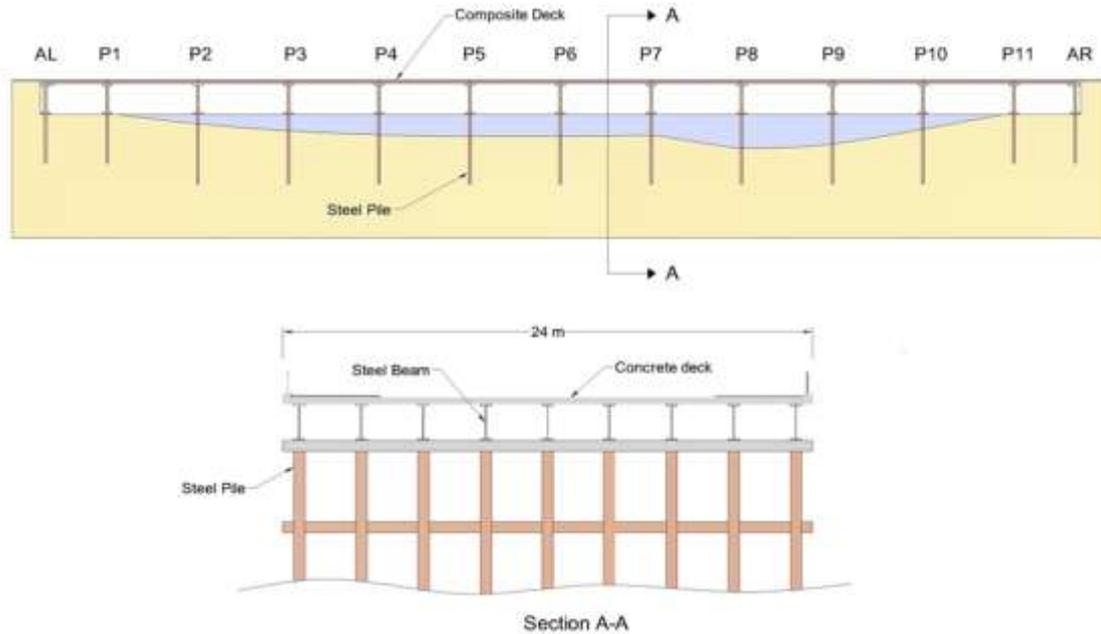
Fig. 1: A representation of Showa Bridge in Japan

shown in Fig.1. The 304 m long bridge consisted of 12 composite simply supported spans with a constant breadth of 24 m. Except for the side spans, which had a length of about 15 m, all other spans had a length of about 28 m. Each span consists of nine steel girders, each of which is supported by one steel tubular pier at both ends with 610 mm outside diameter and a variable wall thickness of 16-9 mm

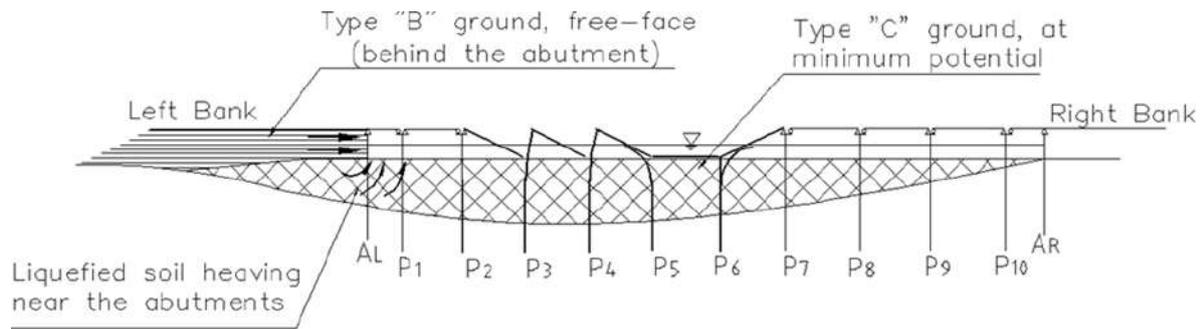
Fig. 4: Liquefaction profile of Showa bridge [6]

Although no consensus has been reached about the cause of the collapse, however, and based on the testimony of a reliable eyewitness, the bridge failed about 1-2 minutes after the earthquake, which rules out the collapse due to the inertia during the shaking of the earthquake [19,20]. Furthermore, preliminary site investigations have shown that the loose sandy soil beneath the bridge liquefied up to a depth of 10 m, which is the maximum depth for liquefaction to occur [6], see Fig 4. The figure shows that the liquefaction depth near the left bank was deeper than that near the right bank.

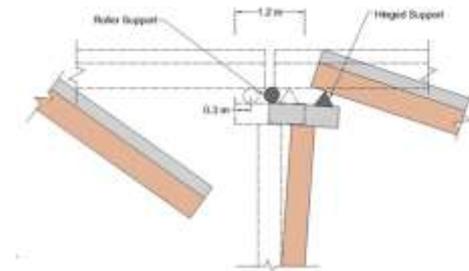
Fig. 5: Effect of lateral spreading during liquefaction.

literature have confirmed that the soil has spread latterly heading towards the center of the river, thus pushing the piles sideway and causing bending stresses. This failure hypothesis has been adopted by a number of researchers such as Fukuoka [16], Hamada and O'Rourke, [22] and Yasuda and Berrill [23] amongst others as the main failure mechanism.

However, and since the collapse occurred in piers P_5 and P_6, which were located near the center of the bridge, where the lateral spreading is minimal, and didn't occur in piers near the abutment particularly P_2 and P_3, where the lateral spreading is expected to be high. Thus, this hypothesis can be considered as inaccurate, still, it can explain the falling of girders between piers $P_2 - P_3$ and $P_3 - P_4$ into the river. Fig. 5 shows that the lateral pressure exerted by the soil might have bent the pile sideways, and since the girder is supported by a roller support from one side and restrained against horizontal movement by a hinge from the other side, the movement of the pier may have stripped the girder from its support. According to Fukuoka [16] it only takes a horizontal movement of around 30 cm to dislodge the girder from its support, see Fig.6. As for piers P_5 and P_6, a different failure mechanism is proposed later

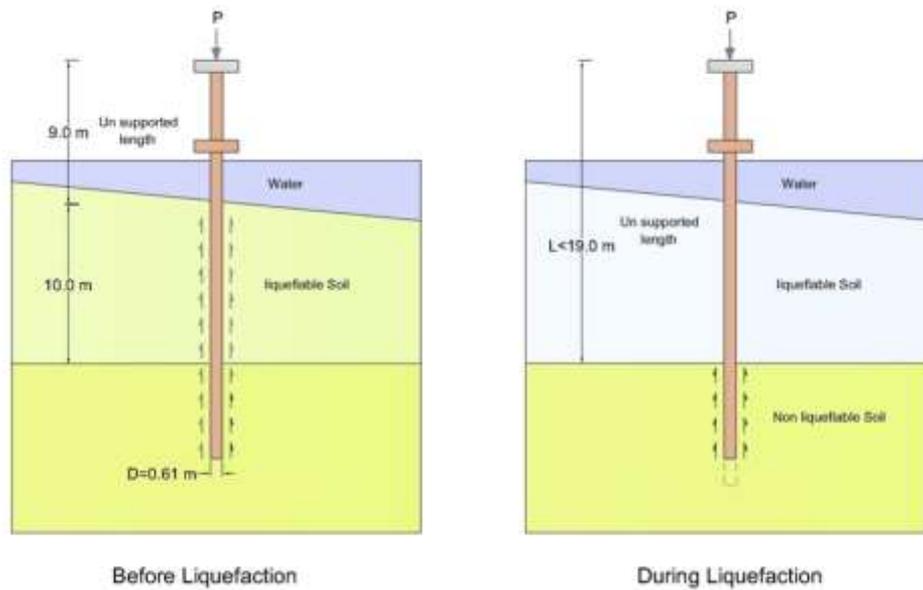
Fig. 7. Effect of liquefaction on the shaft capacity of a single pile

In case of Showa Bridge, when soil liquefied, the piles immediately lost about 10 to 5 m of their surface friction. That is around 60%-30% of its total capacity, see Fig. 7. As stated earlier, and according to Fukuoka [16], the movable ends (roller supported ends) of girders between piers $P_2 - P_3$ and $P_3 - P_4$ have dropped into the river, while the fix ends have remained on the top of the piers, see Fig. 3. In order for that to happen, the piers must have either moved to the right or settled down. Therefore, and due the considerable loss of capacity caused by liquefaction, a bearing capacity failure may have occurred, and the piers could have settled down causing the movable ends of the girders to drop into the river, see Fig. 8. Furthermore, and as shown in fig. 4, the depth of liquefaction near the right bank was less than that near the left bank. Thus failure didn't take place in spans near the right bank. However, there is no information within the literature regarding the amount of settlement. Therefore, this theory cannot be confirmed. As for the span between piers $P_5 - P_6$ which has completely dropped into the rivers, a different failure mechanism is suggested and it will be discussed next.

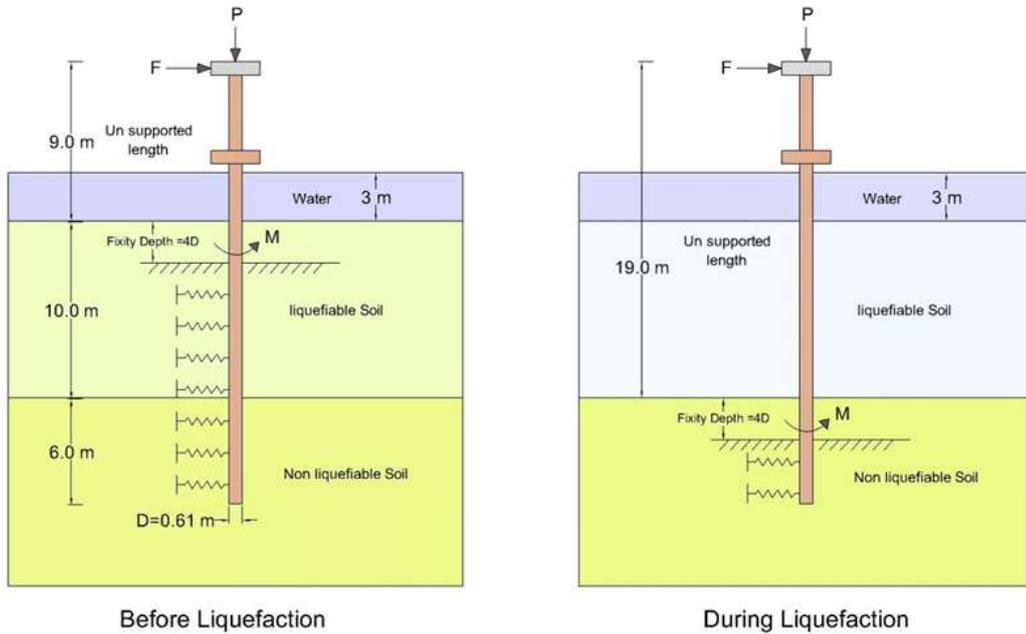
Fig. 9. Effect of liquefaction on the effective length of a single pile

Furthermore, and based on the boundary conditions of the pile, which can be considered as fixed at the bottom and free to move at the top, the boundary conditions factor k must be taken as 2. Due to the increment in the unsupported length and taking into account that the pile's wall thickness varied between 16 mm at the surface of the ground and 9 at the non-liquefiable soil layer, the pile has lost about 83% of its buckling capacity, which most likely has led to the collapse of the piles near the center of the bridge. Although, during liquefaction the pile has lost around 60% of its total capacity, however, and unlike loss of capacity which leads gradually to settlement, buckling failure is sudden and can occur instantaneously. Therefore, it can be concluded that the most likely cause of the collapse of piles $P_5 - P_6$ is buckling.

In the case of Showa Bridge and due to liquefaction which has increased the unsupported length of the pile as shown in Fig.9, the natural period of the bridge during liquefaction has increased up to about 2.5 times that before liquefaction. However, this increment reduced the acceleration imposed on the bridge drastically, and thus the lateral force induced by the earthquake, see Fig. 10.

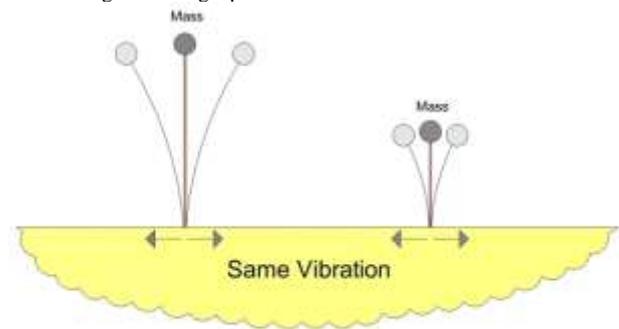
Fig. 11. Effect of the increment in length on the natural frequency and time period

Although, the unsupported length of the pile was doubled during liquefaction, which implies that the applied bending moment should have been also doubled, however, as stated earlier the increment in the natural period has decreased the lateral force, and thus, the increment in the unsupported length was cancelled out by the reduction in the lateral force. Therefore, the bending moment imposed by

the lateral force was almost the same before and during liquefaction. That's why the bridge didn't fail during earthquake, since the applied bending moment remained within the design limits.
