Association between Lineaments and Groundwater Intrusion into Tunnel Built in Granitic Rock Mass

H. Hussin^{1,2*}, M. H. Arifin¹, T. A. Jamaluddin¹, M. F. A. Ghani¹, N. Ismail³

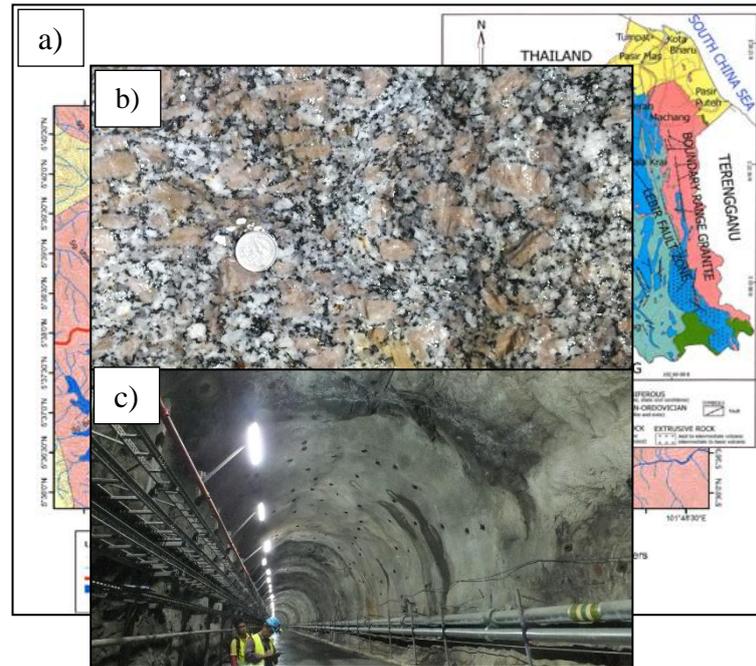
Fig. 1: The figure shows a) Geological map of study area [16], b) close up view of granite rock observed in study area, c) view inside the tunnel

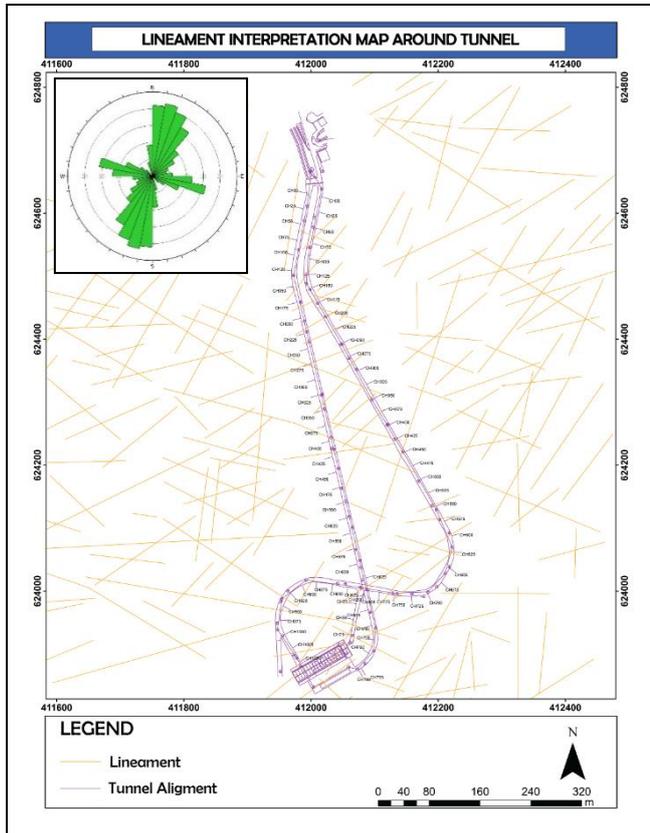
Fig. 4: Lineament interpretation map from satellite image. Four sets of lineaments oriented in NW-SE, NE-SW, E-W and N-S as shown in rose diagram
