Analysis of Cracks on a Fractured Surface of the Vehicle Crankshaft Using the Finite Element Method

Husaini*, T.E. Putra, Zulfikar

Abstract

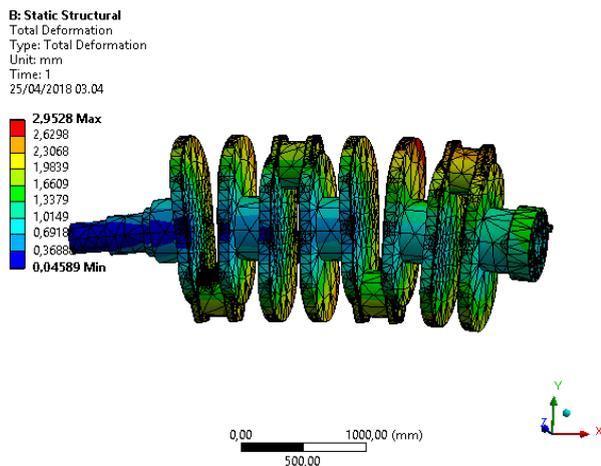
Fig. 13 : Deformasi

Finite element analysis results show that the maximum strain value was 3892×10^{-3} caused by the initial crack in the radius of the crank pin, making it the most critical area when the load was applied as seen in Figure 12. The maximum deformation value was 2.952 mm, as shown in Figure 13.
