Influence of dike slope on the development of infiltration water and erosion processes during overtopping tests

Abstract

Keywords: Dike; Horizontal Erosion Process; Overtopping Failure; Pilot Channel; Vertical Erosion Process.

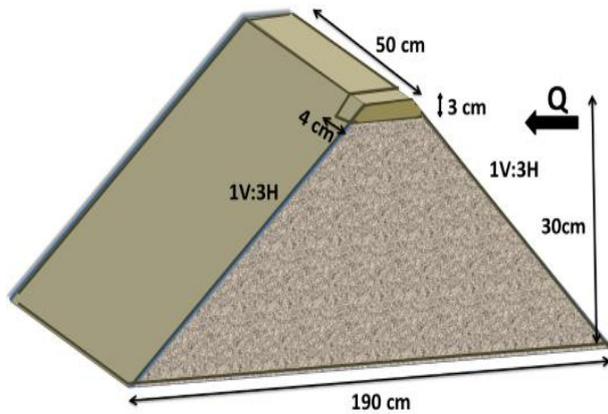
Fig. 1: Geometry of Dike Construction with Pilot Channel Location (Shaded Area) For E1.

Dikes with large dimensions tend to erode faster due to high turbulence intensities. Bigger grain size increases the widening of the breach channel because of the contribution of sliding failure in collapses downstream slope. A series of embankment tests were constructed in in the Dawa Reservoir, Chuzhou, Anhui province, China to notice the development of erosion process inside the dikes constructed with cohesive materials [19]. They divided the behavior of dike failures into three; headcut failure in dike materials, 'helix flow' in side of breach channel and side-slope failure in the centerline of breach channel. The author has investigated the effect of inflow discharges on the development of negative pore water pressure and water content inside coarse sand embankment. A pilot channel was cut along the PVC flume channel to initiate the spatial overtopping test. He observed that the higher inflow discharges increased the volumetric water content faster than that for lower inflow discharges and thus further decreased the matric suction for the higher inflow [20]. The main goals of this study is to describe the mechanism behavior of erosion processes as well as the distribution of vertical and horizontal water levels inside pilot channel of sand dike under two different dike slopes of 1V:3H and 1V:2.5H. The dike slopes of 1V:3H and 1V:2.5H are termed as "E1" and "E2", respectively.

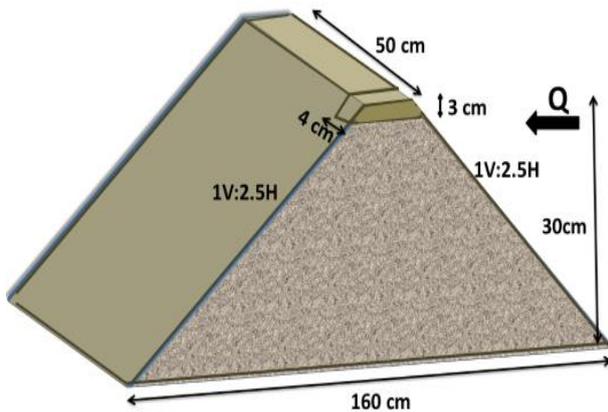
Fig. 2: Geometry of Dike Construction with Pilot Channel Location (Shaded Area) for E2.

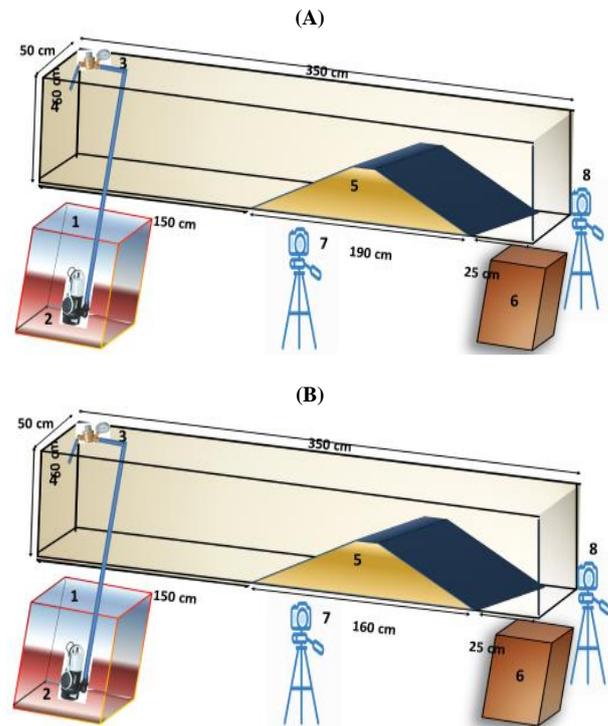
The upstream and downstream slopes dimensions are identical for both slopes under constant inflow discharges of 30L/min. The flume channel is supplied with water from Flow meter connected with the maximum pump discharge of Q= 70l/min. The sediment box is placed at the end of the flume channel to collect the eroded materials during overtopping test. The developments of the lateral and vertical breach channel as well as the distribution of water levels are recorded and analyzed through two digital cameras installed in front of the PVC flume channel and downstream slope, respectively as shown in Fig. 3.

Fig. 3: Component Parts of Flume Channel: 1) Water Tank, 2) Discharge Pump, 3) Flowmeter, 4) Flume Channel, 5) Dike Construction, 6) Sediment Tank, 7, 8) Camera for: A) E1, B) E2.

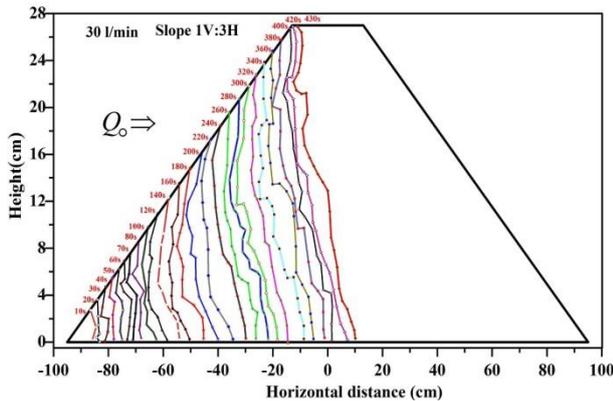
Fig. 4: Water Flow Infiltration inside Dike for Slope of E1.

Fig.4 and fig.5 show the infiltration of water levels inside the dike for E1 and E2, respectively under the constant inflow of 30L/min, while infiltration water transmitted from the toe of the upstream slope until dike crest. The infiltration water is captured through using digital camera installed in front of the PVC flume channel. Although the development of breach channel is dependent on the changeable water level in the river, the constant inflow could be applied in practice use for simplicity. The constant inflow discharges continued until the end of tests. The Y-axis represents the dike height plotted against the X-axis of horizontal dike length during certain times of transient water levels in seconds. The infiltration of water helps to increase volumetric water content and decrease soil suction inside soil particles at each time during overtopping tests for E1 and E2. Consequently, the percentage of water content increases and a saturation process occurred faster for both tests. The vertical soil water pressure migrates the infiltrated water from particles of the lower tension zone into the soils of the high

tension zone in which speed and rise of water penetration are dependent basically on soil permeability. As the infiltration process increases, the permeability of soil to water infiltration increases and thus a large amount of soil particles are filled up gradually with phreatic water level for the whole dike construction. For E1, the infiltration process is faster filled up the soil particles for E1 than that for E2 in the toe and the middle of the upstream slope due to the easy water infiltration into dry soil through the inclination flat slope. The heights of water level are 3 cm and 2 cm at $t = 10$ second for E1 and E2, respectively. The phreatic water level for E1 is reached the middle of the upstream dike slope at $t = 200$ second while for E2 it is contacted at $t = 220$ seconds. The shear strength of soil starts to decrease gradually and thus the instability of dike slope and breach channel evolution occurred inside pilot channel and expanded in downstream and upstream slopes.

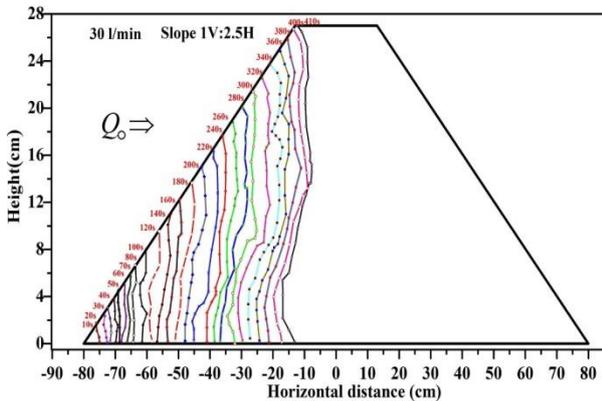
Fig. 5: Water Flow Infiltration inside Dike for Slope of E2.

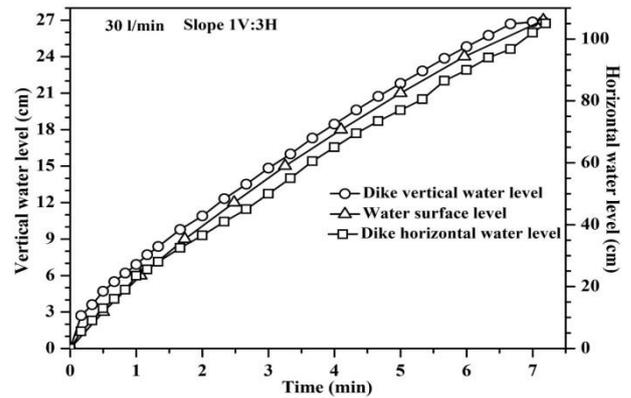
Fig. 6: Distribution of Water Surface Levels for Slope of E1.

Fig.6 and fig.7 show the distribution of vertical and horizontal water levels inside dike soil for E1 and E2, respectively. The vertical water level is measured from the toe of upstream slope, at $t = 0$ second, until a maximum value in dike crest. The horizontal water level is calculated from the beginning of entering water in upstream slope toe and through the horizontal distance of dike length till the maximum value in the toe of downstream slope. The horizontal water level is penetrated soil particles faster than vertical levels for both slopes tests because the gravity reduces the raising of the vertical water level while soil voids in the horizontal level are located in the base of dike construction and thus eliminate the effect of gravity. Consequently, more voids are saturated in the horizontal direction of dike length for both E1 and E2. The soil particles are distributed first in horizontal direction and then transferred up into particles in the vertical direction. For E1, the vertical and horizontal water levels in the beginning of water infiltration at $t = 1$ minute are 6.9 and 23.5 cm, respectively, while in the middle of dike height, they are 16cm and 55cm at $t = 3.33$ minutes, respectively. In the dike crest at $t = 7.16$ minutes, the vertical water level increased into 26.9 cm and the horizontal water level climbed into 105 cm in the transition area between upstream and downstream slopes. The vertical water levels for E1

and E2 are faster in the toe and the middle of the upstream slope due to the faster water saturation process in flat slope of E1 in which the vertical water levels for E1 and E2 are 2.7 and 1.7cm, respectively at $t = 0.166$ minutes. The differences between vertical levels for E1 and E2 are decreased gradually after $t = 2$ minutes in which both vertical levels are nearly identical at $t = 6$ minutes as shown in fig.8 while The vertical water levels are 24.82 and 24.8cm, respectively for E1 and E2 for the latter time. The permeability of saturated voids to infiltration water is reduced due to the constant crest length and thus smallest dike volume near the dike crest for E1 and E2. At the dike crest, the vertical water level is contacted faster for E2 than that for E1 at $t = 6.83$ and 7.16 minutes, respectively. This is due to flat slope of E1 that raising the vertical level faster in the toe of upstream slope and the middle of dike slope. The large horizontal distance of E1 delayed the rising of vertical water level, compared with E2, near dike crest due to the remaining non saturated voids in the transition area between upstream and downstream slopes and downstream slope, and thus decreased water velocity and turbulence. Contrarily, the horizontal water level is clearly faster in E1 than in E2 at $t = 1$ minute as shown in fig. 9 with horizontal water levels of 23.5 and 13.5 cm, respectively. Particles voids near the upstream slope are stiffer in E2 than those in E1 due to the steep slope of the previous slope and thus deaccelerate the horizontal water level. The steep slope of E2 reduces the easiest infiltration process because of the particle's position against gravity.

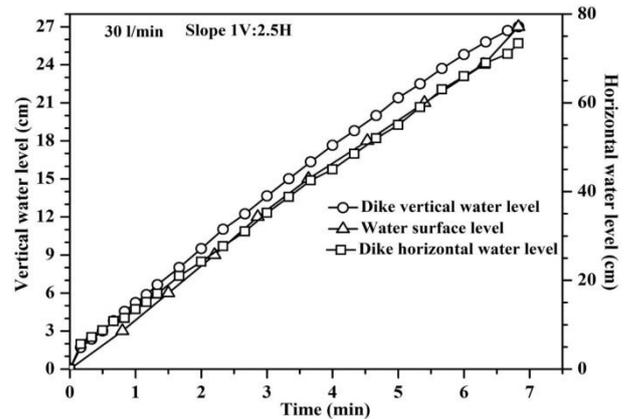
Fig. 7: Distribution of Water Surface Levels for Slope of E2.

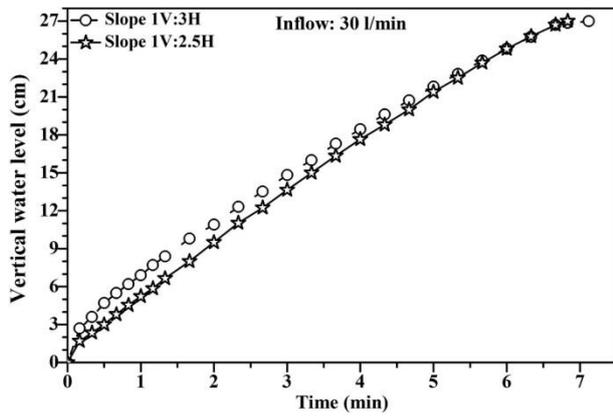
Fig. 8: Comparison Results between Vertical Water Levels for E1 and E2.

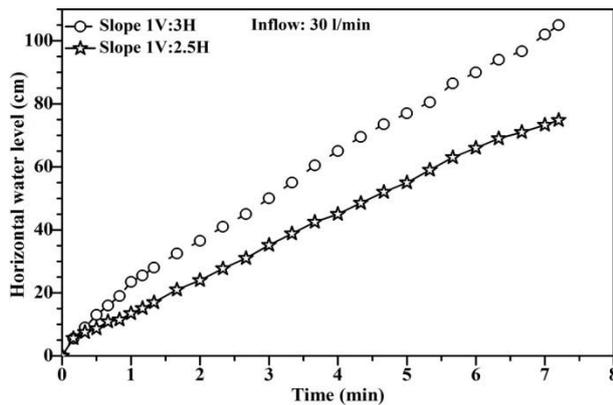
Fig. 9: Comparison Results between Horizontal Water Levels for E1 and E2.

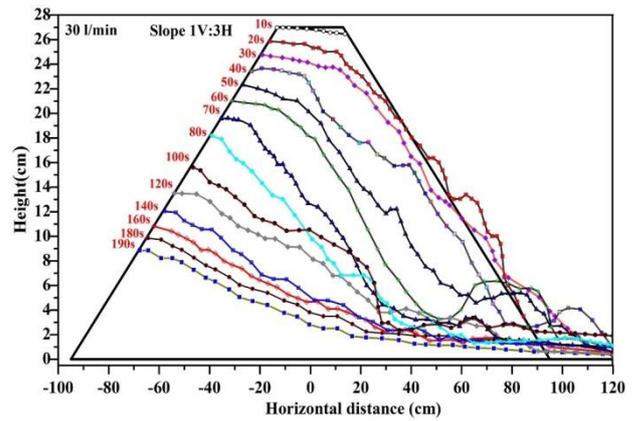
Fig. 10: Dike Breach Profile in Vertical Erosion Process of E1.

Fig. 10 and fig.11 show dike breach profile of vertical erosion process for slopes of E1 and E2, respectively recorded with side camera. The vertical erosion for dike profile is plotted against the horizontal distance of the dike length of 175cm. The breach channel started during the water flow cross inside the pilot channel at $t=0$ second downward into downstream and upstream slopes. The processes of eroded materials for E1 and E2 are moved slowly at $t=10$ seconds with small amount of sediments transported along the downstream dike crest as debris flow. At $t=60$ seconds, the erosion rate reached the middle of the downstream slope due to accelerate the breach flow over the lower part of downstream slope in which huge parts of the downstream slope collapsed. The breach channel is then enlarged in downstream and upstream slopes in latter seconds. Almost half of dike body is eroded due to horizontal and vertical erosion process in 120 and 100 seconds for E1 and E2, respectively, with huge increasing of the tailwater wedge of sediments eroded along the flume channel in which the sediment materials transported into sediment box. The enlargement of breach channel, extended in the upstream slope, is continued until the breach profile of dike became constant with negligible erosion process at $t=190$ and 180 seconds for E1 and E2, respectively. At these time periods, the height of dike crest is almost disappeared due to progression of water velocity. The final dike breach profile is similar for all dike slopes at the end of erosion.

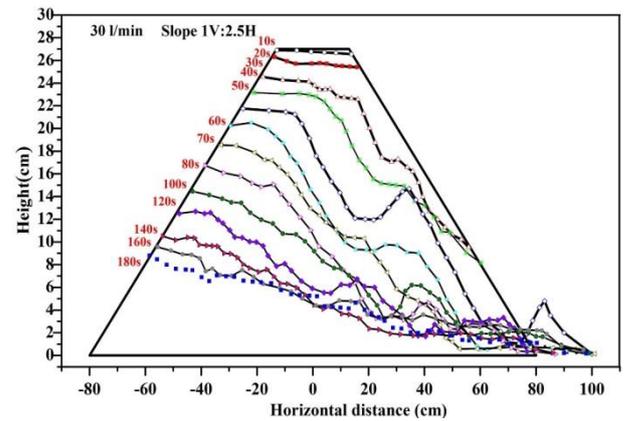
Fig. 11: Dike Breach Profile in Vertical Erosion Process of E2.

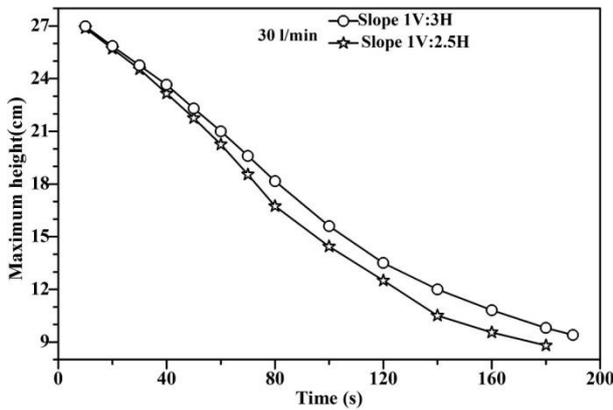
Fig. 12: Comparison Results of Lowering Dike Heights inside the Pilot Channel.

Fig. 12 shows the comparison reduction of dike height between dike slopes of E1 and E2 due to vertical erosion process inside the pilot channel. The slight reductions of dike heights in dike crest, at $t=10$ second, are 26.97 and 26.87 cm for E1 and E2, respectively, are occurring due to high material quantity and lower water velocity. The downstream side slope failure is occurring distinctly at $t=40$ second, due to the development of water content inside particles, while the dike crest heights decreased in 23.65 and 23.15 cm for E1 and E2, respectively. The process of longitudinal breach channel for E2 is faster than for E1 in the middle and toe sections of the downstream slope due to the effect of a steep slope in which the dike heights are 13.5 and 12.5 cm for E1 and E2, respectively at $t=120$ second due to increase water velocity above E2 higher than that for E1 and thus the energy slope is higher. The flow condition in the dike crest is transitional and changed into supercritical flow in the downstream dike slope and thus the lateral erosion accelerate in the downstream direction faster for E2. During this flow condition, the soil shear strength is decreased and the vertical downstream slope is saturated enough to overcome the soil resistance stress while material gradually eroded and transported along the toe of the downstream slope into sediment box. The rate of water velocity is decreased gradually in the end of erosion at $t=190$ and 180 seconds due to the continued reduction of dike height near the toe of the downstream slope in which the material eroded mechanism are stabilized with dike heights of 9.4 and 8.8 cm for E1 and E2, respectively.

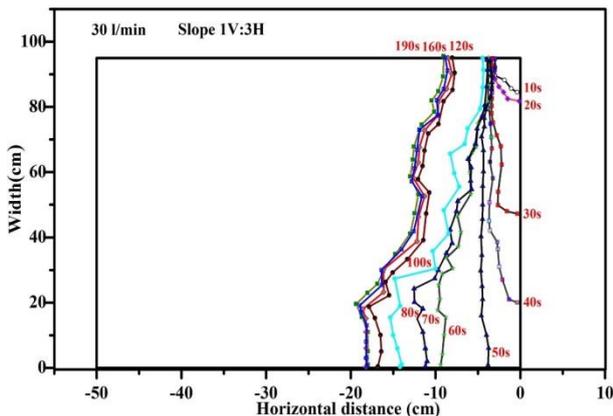
Fig. 13: Reduction of Dike Width Due to Lateral Erosion Process for E1.

For better understanding the behavior of dike soil erosion, 3D fully spatial tests are highlighted and recorded with a camera in front of downstream slope. Fig. 13 and fig. 14 represent the development of lateral erosion process during overtopping tests for E1 and E2, respectively. The reductions of dike width are plotted against the horizontal width distance of 50 cm for E1 and E2. The process of lateral erosion started with water crossing the pilot channel at $t=0$ second. The reductions of widths are less in the beginning of overtopping failure for both E1 and E2, while the main erosion process for this period is vertical erosion process due to the quickly saturation of dike crest layer below pilot channel. The noticeable reduction of dike width occurred at 30 and 10 seconds for E1 and E2, respectively. At these moments, the toe of downstream slope is stable due to lower water velocity while the horizontal erosion occurred in dike crest. At $t=50$ and 20 seconds, the dike width expanded laterally in the middle and toe of the downstream slope for E1 and E2, respectively. This is because of increasing shear stress and thus increasing the undermining of breach channel side slopes. The vertical dike slope is fully saturated in later seconds; consequently, huge amount of soil materials is collapsed and fall down into the bed flume channel. At the end of later erosion process at 190 and 180 seconds for E1 and E2, respectively, the erosion rate inside dike was stabilized and the hourglass breach shape is formed due to negative pore water pressure of soil.

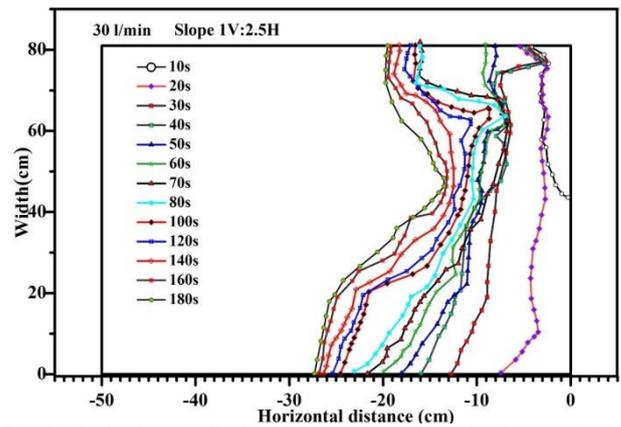
Fig. 14: Reduction of Dike Width Due to Lateral Erosion Process for E2.

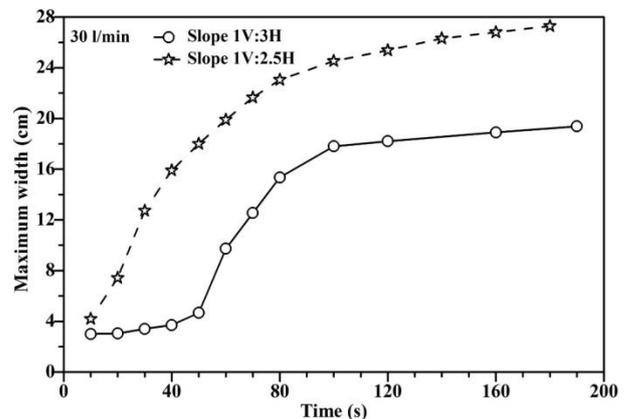
Fig. 15: Comparison Results of Reduction Dike Widths inside Pilot Channel.

Fig. 15 shows the comparison reduction of dike width for E1 compared with that for E2. The effect of dike slope in width reduction, during the early erosion process, is less visible in top and invisible in the middle and toe sections due to less turbulence and materials resistance in the dike crest at $t=10$ seconds for E1 and E2 in which the dike widths are 3 and 4.19 cm, respectively. The toe and top sections are progressively saturated due to increase velocity and tractive shear stresses in downstream slope with noticeable differences of dike widths of 3.04 and 7.42 cm at $t=20$ second for E1 and E2, respectively. Consequently, most of materials collapsed into the breach channel center due to the steep slope of E2 while most of the transition area between upstream and downstream slopes and upstream slope are eroded at $t=70$ second. The reduction dike widths are 12.54 and 21.66 cm for E1 and E2, respectively. The steep slope of E2 increases the velocity of breach flow over the downstream slope and thus accelerate the breach erosion compared with E1. Over the time, the erosion process is decreased during continuous reduction of dike height due to decrease tractive shear stresses and energy head and thus, erosion slows down at $t=190$ and 180 seconds with dike widths of 19.38 and 27.29 cm for E1 and E2, respectively. From all above figures, the lateral erosion process is faster in E2 than that in E1 due to higher saturation process during overtopping tests, while for E1 the development of breach channel is slow due to flat slope, and thus collapses of materials are delayed.
