Wear Studies of $\text{Al}_2\text{O}_3\text{-ZrO}_2\text{:5CaO}$ Composite Coatings for Tribological Applications

Abhinav^{1*}, N.Krishnamurthy², Ranjana Jain³

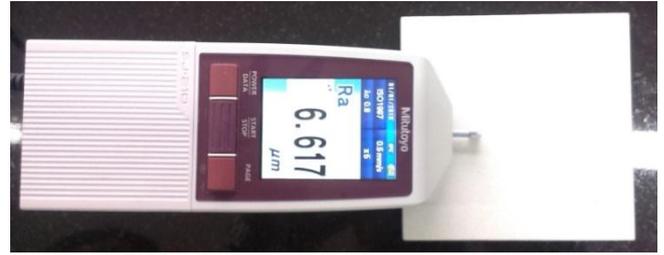
Fig.2: Mitutoyo SJ-210 surface roughness tester.

Scanning electron microscopy (SEM) and X-ray diffractometer (XRD) technique was adopted to do the characterization of the coatings. Primary information viz. coating thickness, micro hardness, porosity, and surface roughness were investigated. The SEM and XRD machine specifications are shown in Table 4 and 5 respectively. The coating error was calculated using empirical relationship and expressed in percent. The micro hardness and porosity analysis were carried out on Clemex CMT, HD model. The Vickers micro hardness was conducted as per ASTM E-384 standard [16], and the test parameters are shown in Table 6. Line intercept method was adopted to determine the average porosity of the coatings. The surface texture of the coated samples was examined using Mitutoyo SJ-210 surface roughness tester as per ISO1997

standard refer Fig.2. The probe travelling speed was maintained at 0.5 mm/s, also some other important specifications of the device are as follows: stylus tip radius: 5µm, detecting measuring force: 4mN, and display type: LCD. On the each sample, 5 trials were done and the average value reported and shown in Table 7.

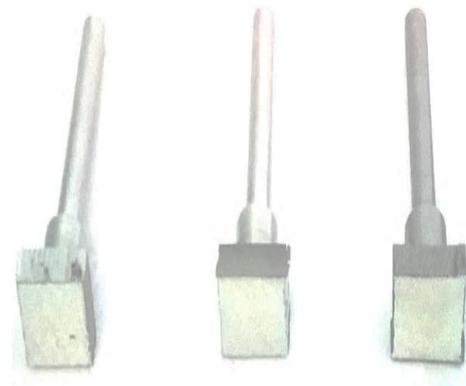
Fig.3: Coated specimens.

In the preparation of wear test samples, the Al-6061 plates were cut into 15mm x 15mm pieces using the isometric cutting tool. These coated pieces were stick to the cylindrical pins using commercially available epoxy resin as shown in Fig.3. Total of 3 specimens were prepared for each coating system, S1, S2, and S3.

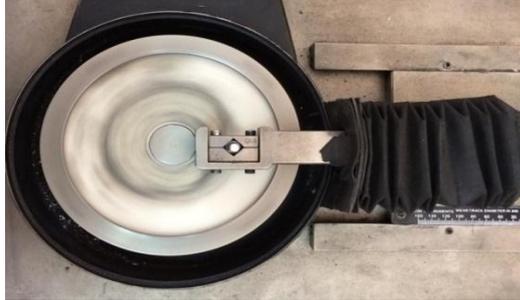
Fig.4: Pin-on-disk tribometer test setup.

The abrasive wear test was carried out on Pin-on-disk tribometer, as per ASTM G132 standard [17]. A commercially available Alumina abrasive disk was used as a counter material whose roughness is determined using Mitutoyo SJ-210. The experimental setup and wear test parameters are shown in Fig. 4 and in Table 7 respectively.

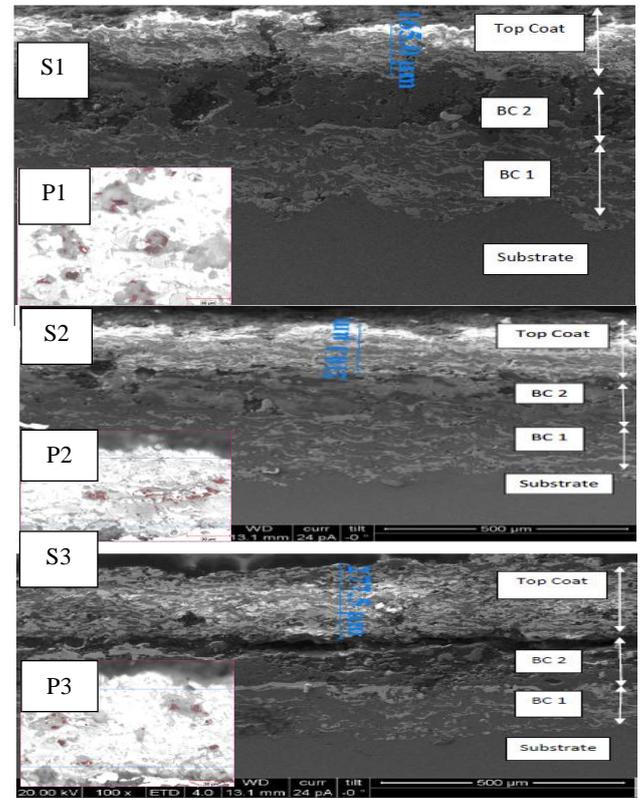
Fig.5: SEM micrograph of S1, S2 & S3 coating thickness and corresponding porosity P1, P2 & P3 of top coat.

The deviation in coating error calculated using an empirical relationship which is as follows: T_{th}/T_{act} , where T_{th} and T_{act} are theoretical and actual coating thickness respectively and expressed in percentage. The actual coating thickness of the coating systems are shown in Fig.5. The coating error, average surface roughness, average micro hardness, average porosity values for the coating system shown in Table 8. Coating error observed more in case of S1 reason attributed to change in operational parameters viz. feed rate, velocity of impinging jets etc. It has been also observed, as the porosity decreases, hardness proportionally increases, this kind of trend is also observed in other cases [4]. It is also observed in the present coating systems, as the coating thicknesses increases the surface roughness of the top coat also increases. R. G. Bayer et al. [18] had developed an empirical relation between surface roughness and wear and found that wear governed by roughness and the orientation of the asperities. Results obtained in the present case is in agreement with above statement.

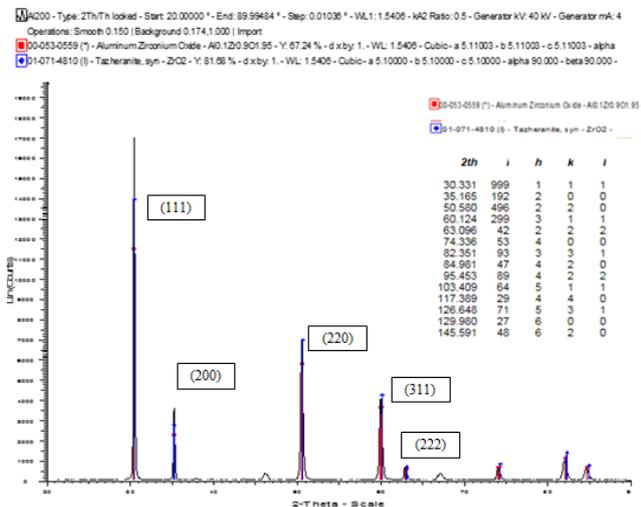
Fig.6: XRD spectrum of $Al_2O_3-ZrO_2-5CaO$.

XRD analysis carried out with Cu-K- α 1 radiation produced at 40 kV and 40mA. The θ -2 θ scan was performed between 20° and 89.99° by step width of 0.01036°. It has been found that phase transformation took place from α - Zirconia dioxide to β - Tazheranite phase within the composite mixture during the plasma coating process. The weight % of β -Tazheranite phase, synthesized from ZrO₂.5CaO found to be 81.08 wt. %. The synthesis of this phase was very novel, and found to minimize the wear mechanism. It is also evident from the XRD pattern [Fig. 6] that sharp peaks and lattice parameters [$a=b=c=5.1000$, $\alpha=\beta=90^\circ$] of composite mixture particles were exist in the cubic crystalline structure with good atomic packing factor. Cubic crystal found offers easy sliding and dislocation as discussed in the forthcoming wear mechanism section [Section 4.2.2].

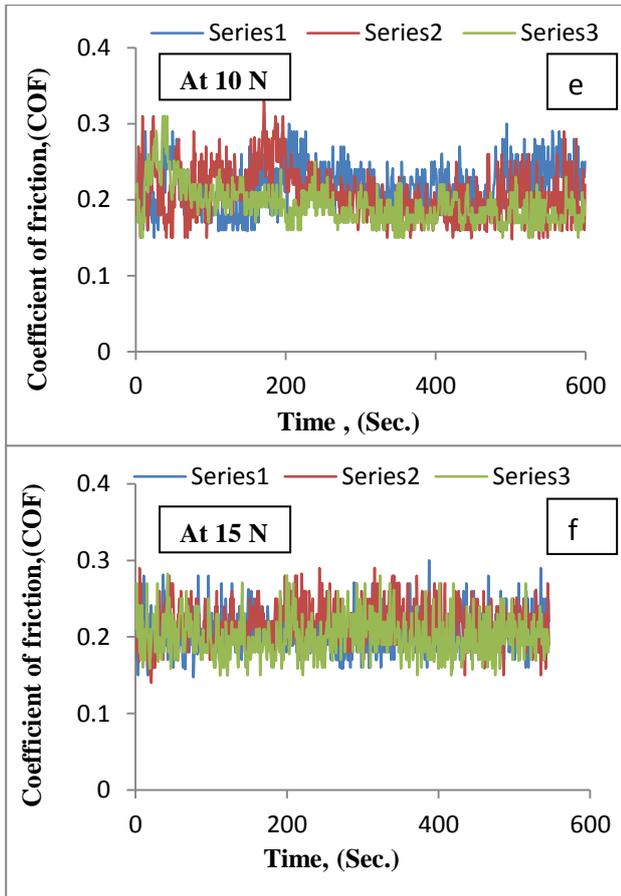
Fig. 7: Wear versus time graph a, b, c, Coefficient of friction versus time graph d, e, f: at 5, 10, 15 N normal load.

The specific wear rates were calculated based on cumulative volume loss/penetration depth of the coating per unit of the applied load and sliding distance [19]. The variation of specific wear rate with load, porosity and hardness is shown in [Fig.10 (g, h, i)]. The cumulative volume loss obtained from the wear versus time data obtained digitally from the computer interfaced with tribometer, and sliding distance was calculated from sliding velocity multiplied with running in time period. It is evident from the graph [Fig. 7 (a, b, c)] that as the load increases wear of the coating increases. The common reason was due to more contact stress established at the interfaces of the asperities at higher load [20]. This can be also understood as follows: Soft phase in the present case zirconia comes under the influence of hard asperities abrasive disk, the soft phase asperities gets squeezed more as the load increases. Mild wear observed between 5 and 10 N normal load and severe wear observed at 15 N load [Fig.7]. Very similar trend of wear was observed from the wear versus time graph with an anomaly at 15 N normal load for S3. Reason of such irregularities can be attributed to the less cohesion between the phases present in the composite mixture and could also be acknowledged due to the continuous change in the profile of the asperities of the coating system [21]. It can be also understood as the coating thickness increases exhibit asymptotic behavior [22]. Another interesting phenomenon observed related to coefficient of friction, and it was found that COF value fluctuate in the range of 0.1 to 0.3 at all the

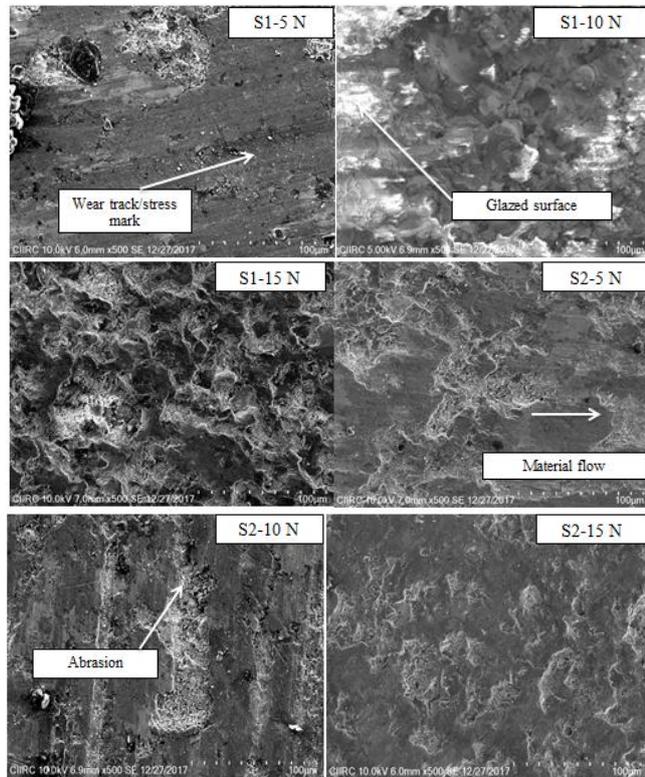
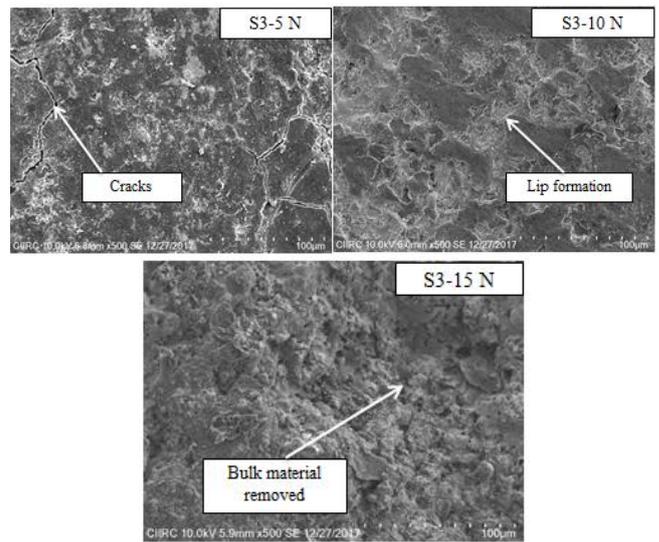
Fig.8: Micrograph of post wear samples S1, S2 and S3 at 5N, 10N and 15 N normal load respectively.

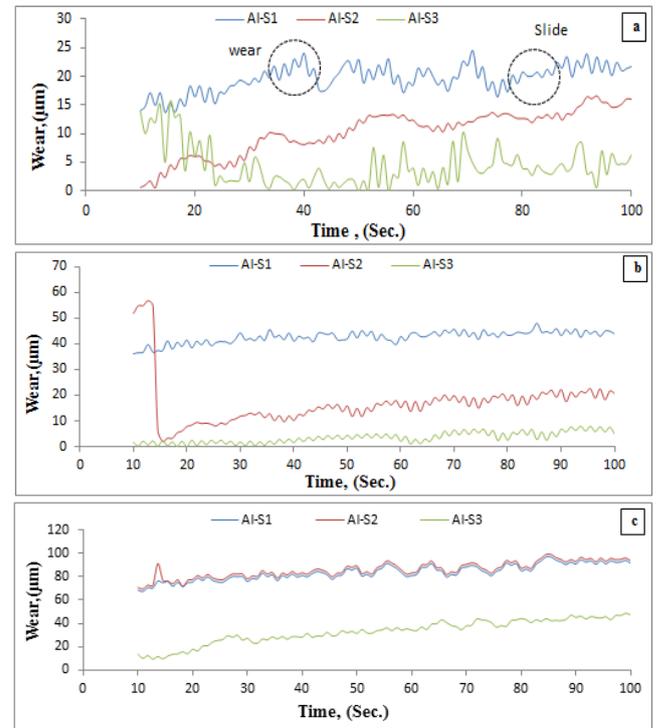
Fig. 9: Enlarged wear versus time graph a, b, & c at 5, 10, 15 N normal load respectively.

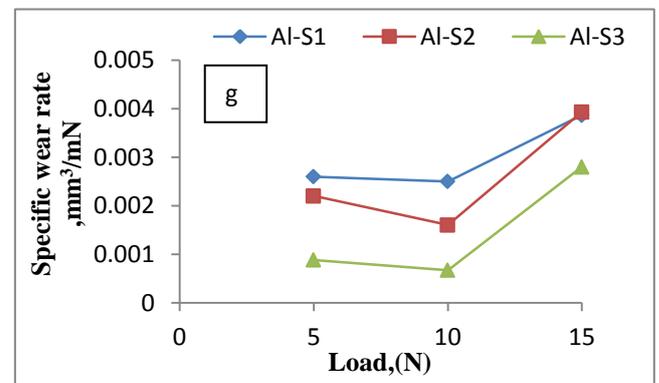
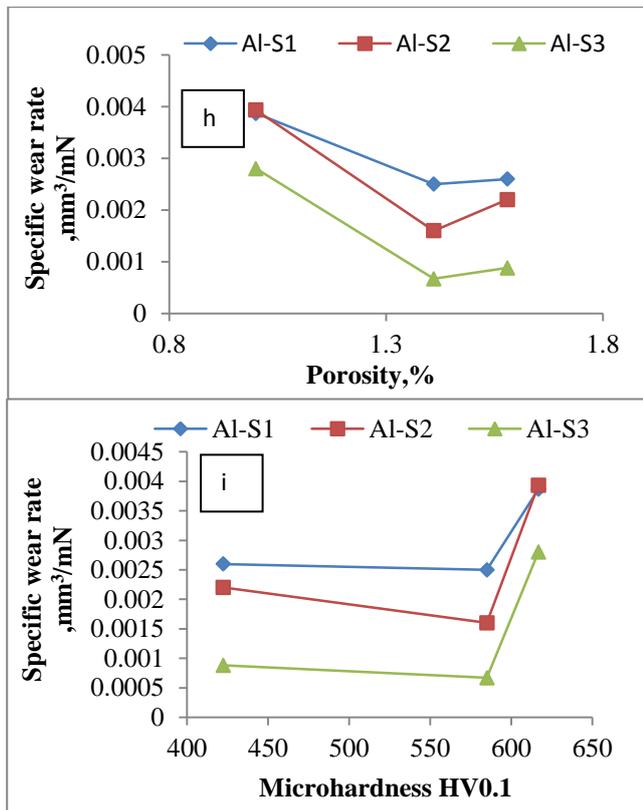
Fig.10: Variation of specific wear rate with d. load e. porosity and f. Microhardness.

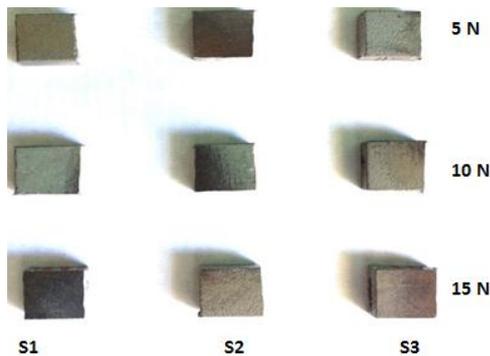
Fig.11: Images of post wear coated samples.

Due to anisotropic behavior of ceramic composition, the interpretation of the wear mechanism is a complex task [23]. In this section, an attempt was made to understand the exact mechanism of composite coatings $Al_2O_3-ZrO_2-5CaO$ tested under Alumina abrasive disk. An interesting phenomenon is acknowledged for all the coating systems. The top coat was subjected to more sliding compared to abrasion. The SEM micrograph [Fig.8] along with the enlarged wear versus time graph [Fig. 9] plot clearly shows that the top coat subjected to frequent sliding and wear. Series of stress mark resulted from slip lines refer Fig 8 (S1-5N,) assisted with plastic flow mark refer (S2-5N, S2-15N & S3-10N). Along with localized plowing refer (S2-10N & S3-15N of materials observed more or less same in all the coating systems. This kind of slip lines are also found in many cases of metals and ceramics [24], and localized delamination of the coat [Fig 8: S2-15N, S2-10N] was happened due to less cohesion strength among the constituents. It was evident from the stress pattern and material flow direction that the wear mechanism has mainly governed my slip, and less twinning within the composite mixture. This phenomenon can be understood as follows, within the composite mixture, Tazheranite is a soft phase and it assist in slip of planes. The slip phenomenon principally occurs when slip planes oriented parallel or at right angle to the normal load and hence no plastic deformation [24]. Above investigations also supported by the enlarged wear versus time graph [Fig.9 a,b,c] in all the coating systems. Since all the phases present in the composite mixture found to coexist in the same face centered cubic crystalline structure and the slip has mainly occurs in the plane of $\langle 111 \rangle, \langle 200 \rangle, \langle 220 \rangle, \langle 311 \rangle, \langle 222 \rangle$. Also, the topcoat was primary a pure ceramic composition of $Al_2O_3-ZrO_2-5CaO$ the plastic deformation in crystalline ceramics is governed by slip, which finds difficulties due to structural pattern and strong local (electrostatic) potentials [25]. This could also be a probable reason for a very less plastic deformation and more sliding in all the coating system refer Fig.8. The stress mark and wear pattern results on the top surface of the coatings shown in the Fig.8 is in good agreement with the results obtained by Shiv Pratap Singh Yadav et al.[26]. The post wear images of samples shown in Fig.11.
