# Analysis of Operating Noise Characteristics and Contribution for Automotive Seat Backrest Adjuster

**Background/Objectives:** This study involved basic research on operating noise in an automotive seat backrest adjuster through analysis of noise sources, noise source contributions, and seat pad noise reduction effects.

**Methods/Statistical analysis:** The test product was a driver seat of 3300cc commercial sedan. First, basic data is obtained through analysis of driving mechanism of seat backrest adjuster. Based on this, vibration and noise characteristics were analyzed by operating test of backrest adjuster, and contribution analysis to noise sources was performed. Finally, by analyzing the effect of noise reduction on the seat pad, the effect of each noise source on the backrest operating noise was determined.

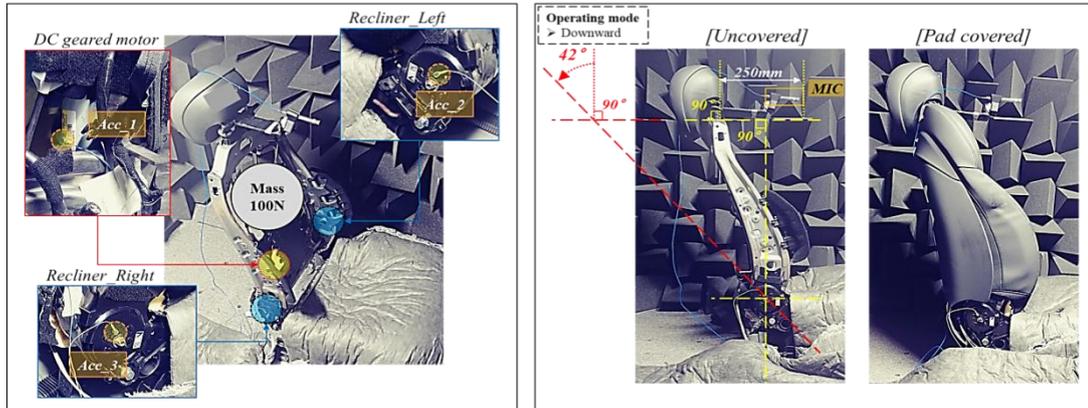
Figure 1: Test mode and sensor position

Figure 1 shows the conditions for the operation test of the backrest adjuster and the sensor mounting position. The test product was the drivers' seat from a 3300cc commercial sedan. The test methodology was as follows: First, the reference position of the seat back was set at 90° with respect to the headrest pole. Next, a load of 100N was applied to the center of the seat back using a dummy. Third, the operating mode of the seat back consisted of a 42° reclining movement from the reference position[10]. Fourth, environmental conditions were as follows: As shown in Figure 2,

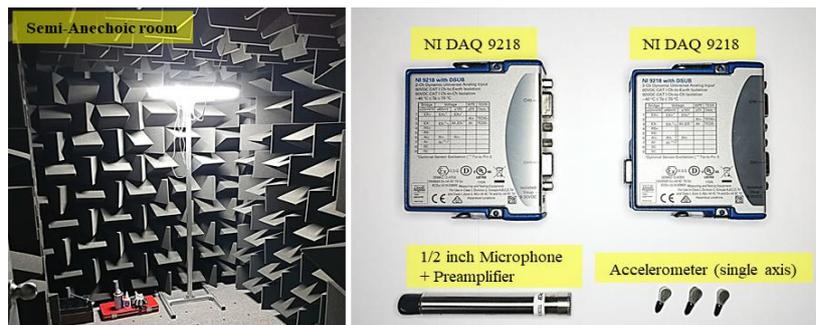
Figure 2: Test room, measurement equipment and sensors

the test room was a semi-anechoic room with less than 30dB (A) of ambient noise. Temperature was maintained at  $20 \pm 2^\circ\text{C}$ , and  $30 \pm 10\%$  humidity. Lastly, in terms of the location of the microphone and accelerometers, the microphone was installed 250mm away from the headrest pole. And the accelerometers were attached to the DC-geared motor and the left and right recliner in the shaft axis direction. The measurement instruments and sensors used in this test were two NI DAQ 9218 (National Instruments Corporation), one 1/2 inch microphone (PCB Piezotronics Inc.), and three single axis accelerometers (PCB Piezotronics Inc.) as shown in Figure 2.

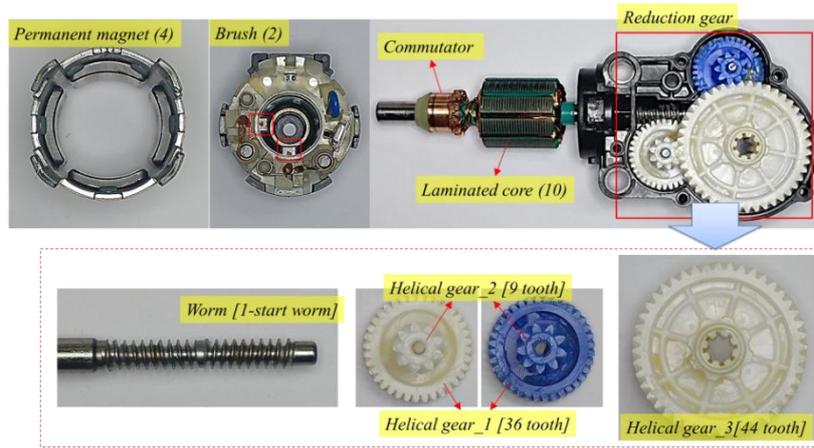
Figure 3: Components of the DC geared motor

A DC geared motor consists of a brush, permanent magnet, commutator, laminated core, and reduction gear, as shown in Figure 3. There were three major noise generation factors: friction noise between the brush and commutator, torque ripple between the permanent magnet and coil, and gear mesh frequency from the reduction gear. First, the frequency of friction noise between the brush and the commutator depends on the angle of the brush and the number of commutator slots. That is, as shown in Fig. 4, as the commutator's slots pass through the brush, events occur that cause noise and vibration as harmonic components of the motor. Equation (1) shows the formula used for obtaining the frequency that occurs when two brushes have a phase of 90°.

The reduction gear consisted of a worm and helical gear as shown in Figure 3. These gear meshes generate a gear mesh frequency, causing noise and vibration. Gear mesh frequency could be obtained using Equation (3).

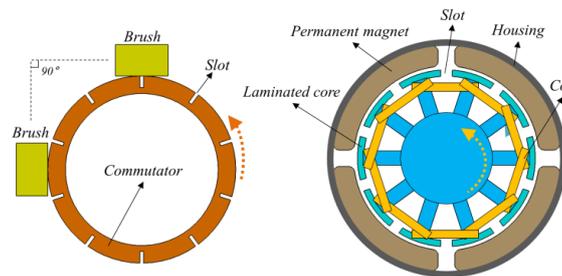
Figure 4: Mechanism schematic of brush-commutator and permanent magnet-laminated core

In the case of torque ripple, when permanent magnets form a magnetic field and a current flow from the commutator to the coil, electromagnetic force is induced in accordance with Lorentz's law, causing rotation. Here, torque fluctuation occurs due to the distance between the coil and the permanent magnet, which is

termed "torque ripple". Torque ripple is determined by the number of poles and the winding of the coil. A 4-pole, 10-slot motor was used in this study, and the torque ripple frequency was derived from Equation (2).

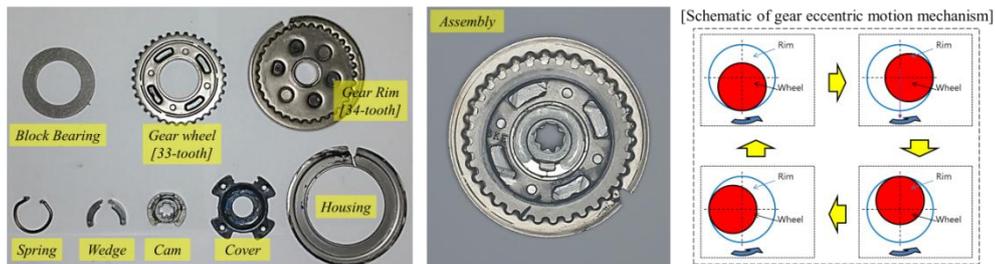
Figure 5: Recliner component and mechanism schematic

Next, a recliner consists of eight parts shown in Figure 5, of which the gear rim and gear wheel form an internal gear, in that the eccentric motion of the gear wheel possesses a mechanism to directly control the movement of the seat back frame. The number of teeth of gear rim and gear wheel were 34 and 33, respectively. The seat back frame moved approximately  $10.6^\circ$  per single revolution of the gear wheel. The gear mesh frequency of the recliner gear could again be calculated using Equation (3). Table 1 shows the frequency components of the DC geared motor and recliner derived from Equations (1) to (3).

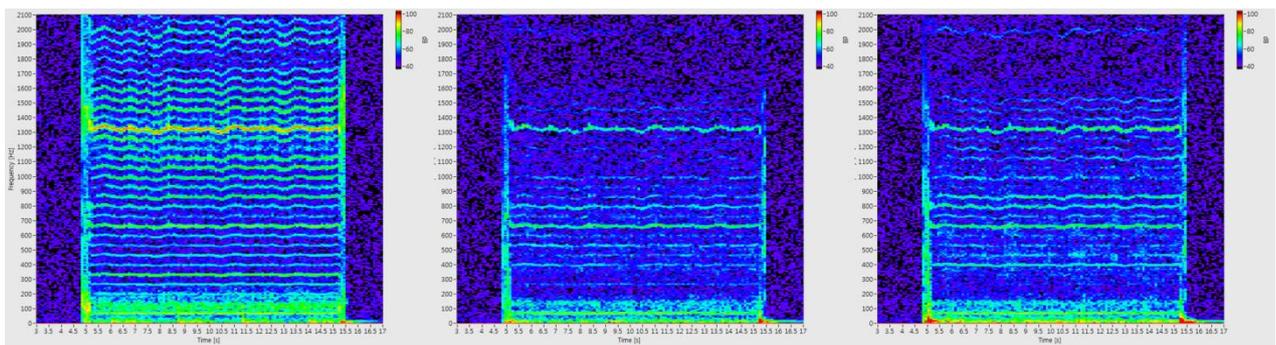
(a) DC geared Motor (Acc\_1)

(b) Recliner\_Left (Acc\_2)

(c) Recliner\_Right (Acc\_3)

Figure 6: Color spectrogram for operating vibration of each component

occurred in each component. First, the 20th order ( $f_{brush}$ ,  $f_{torque}$ ) was the highest in the DC geared motor, and  $f_{rpm}$  was the next highest. Both recliners in the color spectrogram showed high levels at  $f_{recliner, GMF}$ . In terms of the time data and the 1/3 octave band in Figure 7, the overall level of the right recliner was higher than that of the left recliner. It was judged that the right recliner was closer to the motor and thus greatly affected by it. Next the harmonic component of the motor appeared in the recliners, and this was also confirmed by the 1/3 octave band. Lastly, it was confirmed that all the frequency components periodically fluctuated in the time domain. This was attributed to load change due to eccentric rotation of the recliner gear being caused by changing the rotation speed of the DC geared motor.

The operating vibration of the backrest adjuster was analyzed based on the frequency components derived from Section 3.1. Figure 6 shows the color spectrogram for the vibration that

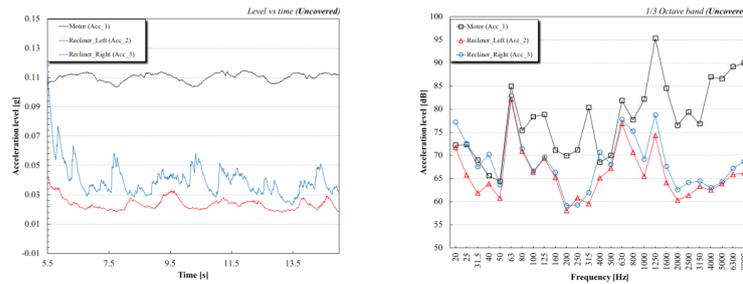
(a) Level vs time [Uncovered] (b) 1/3 octave band [Uncovered]  
**Figure 7:** Vibration data of each component

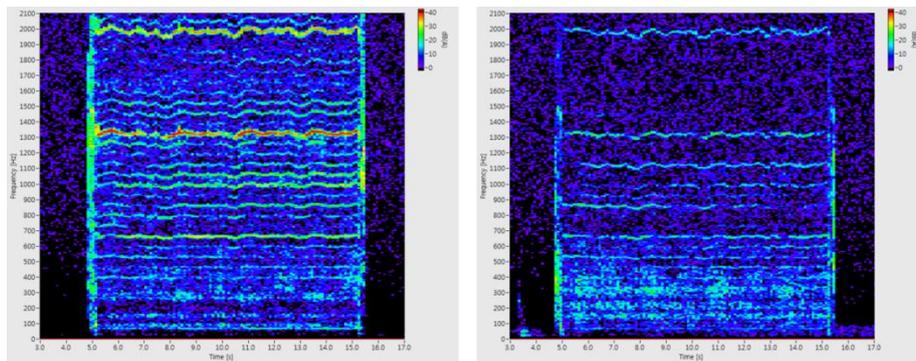
(a) Uncovered (b) Pad covered  
**Figure 8:** Color spectrogram for operating noise of seat back rest

Based on Section 3.2, we analyzed the noise data. Figure 8 shows the color spectrogram for operating noise. The left figure represents the uncovered state and the right shows the pad-covered state. First, noise data characteristics in the uncovered state show that the 20th order of the DC geared motor was dominant, as was the case with the vibration data. In the case of  $f_{rpm}$ , vibration was slightly higher, but noise was not. In addition, there were somewhat higher levels of noise in the 10th and 30th order. This was evidence of a harmonic component generated between the  $f_{rpm}$ ,  $f_{brush}$  and  $f_{torque}$  components, which was predicted by the influence of the electromagnetic field and structure resonance of the motor. Next, the analysis result of the pad-covered state is as follows: The 20th order was again the highest, but the overall level and the 1/3 octave band in Figure 9 show that the overall noise level was significantly reduced. It was judged that the pad absorbed or blocked the harmonic noise of the motor. Also, by comparing the level of each component in the time data in Figure 9, this influence could be visually confirmed. Finally, based on the analysis so far, we analyzed the influence of the pad on the noise contribution of each component. This noise contribution analysis procedure was as follows: First, the sound pressure level corresponding to each frequency component was derived based on the center frequency of the 1/3 octave band. Here, the sound

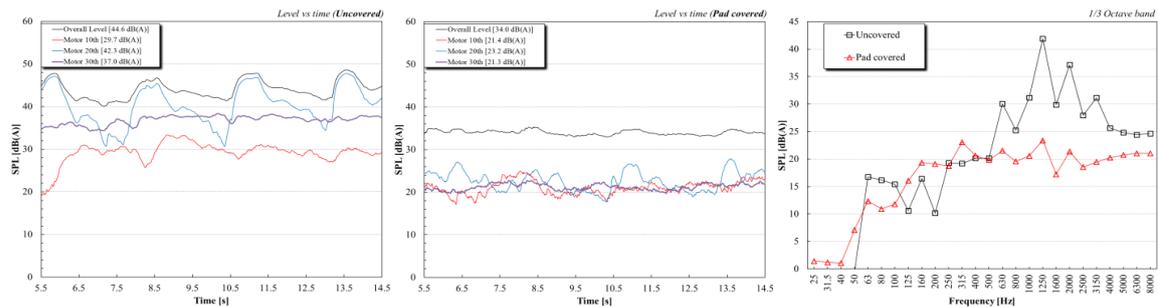
(a) Level vs time [Uncovered] (b) Level vs time [Pad covered] (c) 1/3 octave band  
**Figure 9:** Noise data of each component

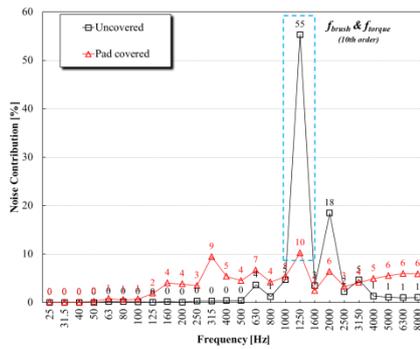
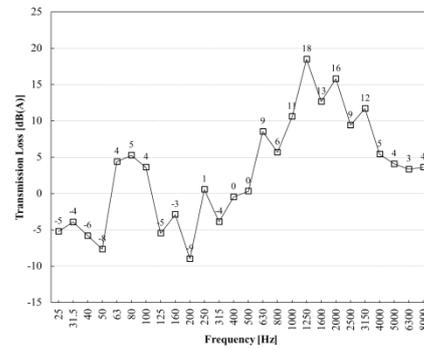
(a) Noise contribution

(b) Transmission loss

**Figure 10:** Analysis of noise influence for each frequency component

The result of the contribution is shown by the graph in Figure 10. In the uncovered state, the contribution of the 20th order was approximately 55% and the 30th order was approximately 18%. Together, these constituted about 73% of total sound pressure and their influence was dominant. On the other hand, in the pad-covered state, the 20th order contributed about 10% and all other frequency components comprised less than 10%. When these were calculated as transmission loss, it was confirmed to be approximately 18 dB(A) in the 20th order and about 16 dB(A) in the 30th order. In conclusion, motor noise, which accounted for more than 70% of the backrest adjuster operating noise, caused considerable energy loss due to the influence of the pad. Of particular note, the noise reduction effect was deemed to amount to about 45% for the 20th order, making it the most influential factor.
